**BUILDING CONDITION ASSESSMENT
10 TALBOT STREET NORTH
SIMCOE, ONTARIO
for
NORFOLK COUNTY**

PETO MacCALLUM LTD.
45 BURFORD ROAD
HAMILTON, ONTARIO
L8E 3C6
Phone: (905) 561-2231
Fax: (905) 561-6366
Email: hamilton@petomacallum.com

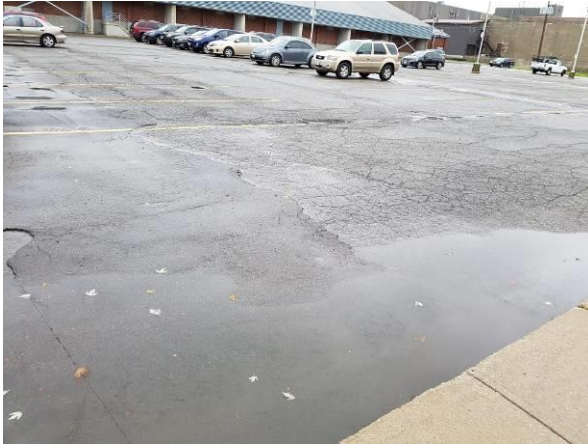
View showing the overall condition of the asphalt pavement with standing water.

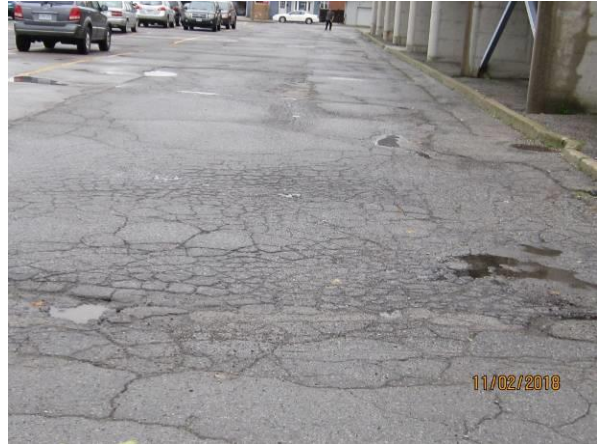
View showing damaged asphalt pavement surface at the north parking lot.

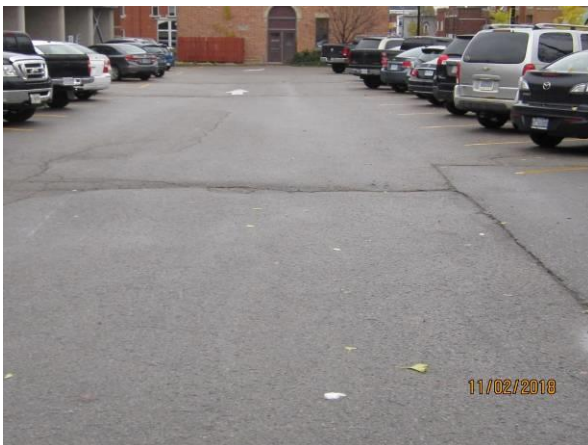
View showing the condition of the south parking lot.

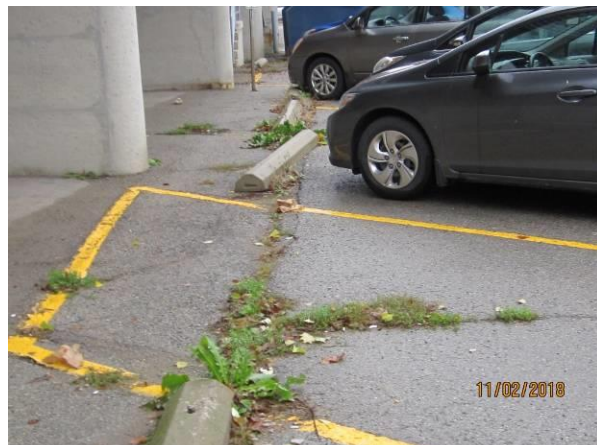
View showing vegetation growth in the asphalt pavement.

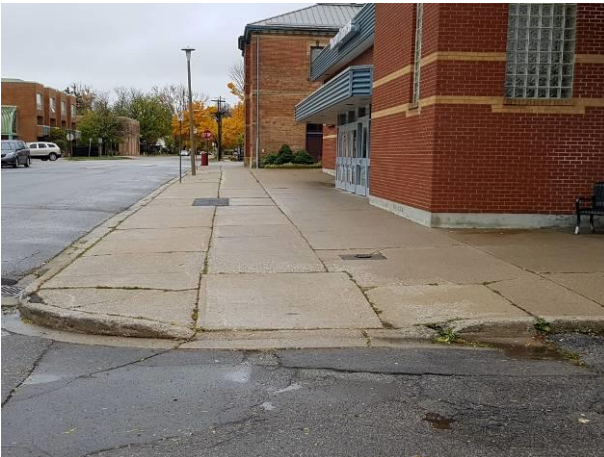
View showing the condition of the concrete slab in front of the building.

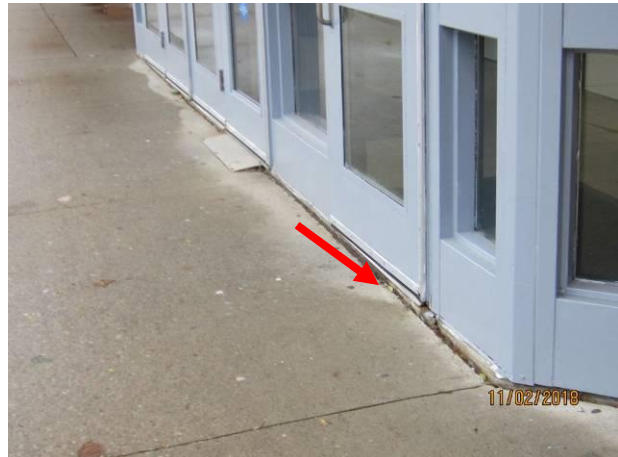
View showing missing sealant between concrete slab and building wall at the east elevation.

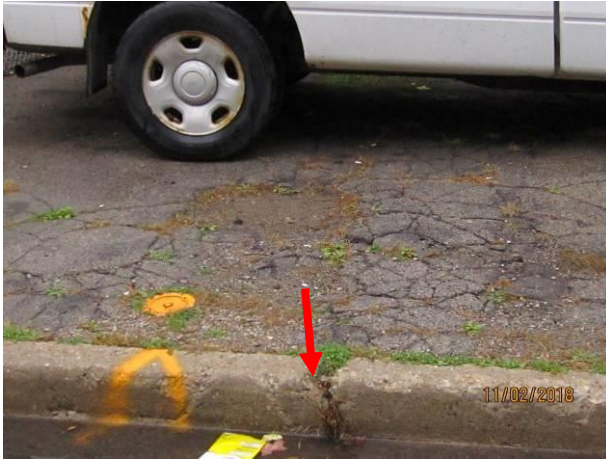
View showing broken curbs and damaged asphalt pavement at the west side of the building.

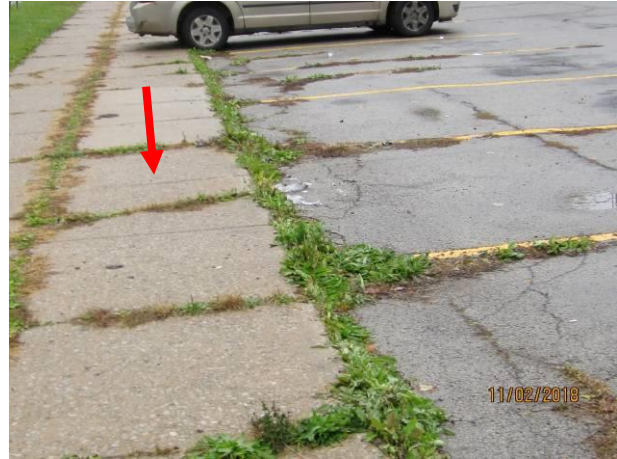
View showing broken, uneven with growing vegetation in the walkway at the west side of the property.

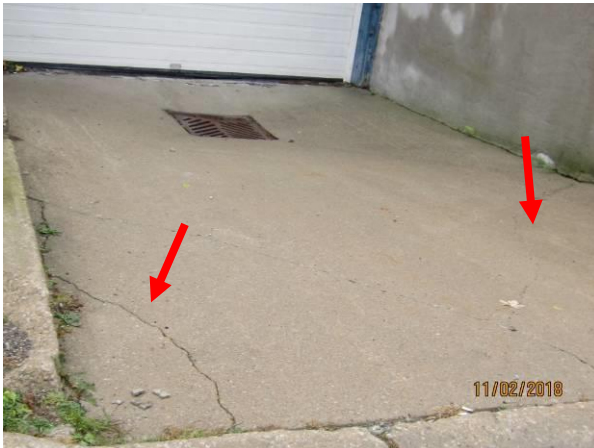
View showing cracked concrete slab in front of overhead door at the west elevation.

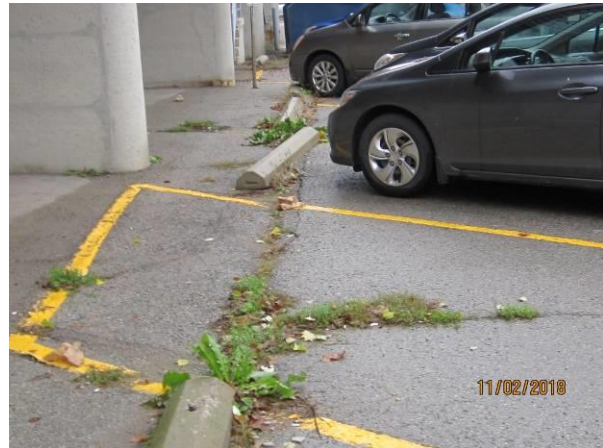
View showing the condition of the precast concrete wheel stops at the south side of the building.

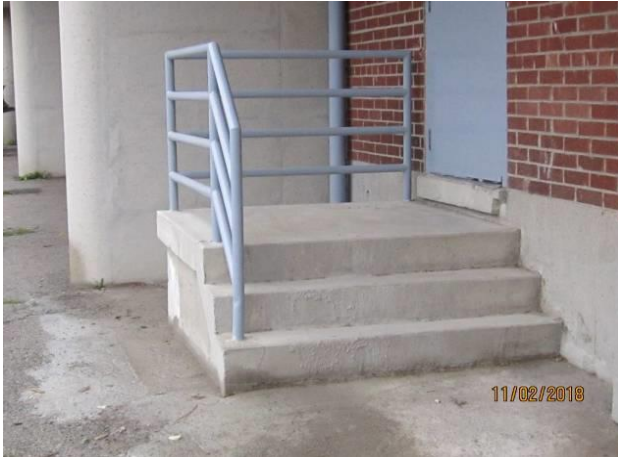
View showing the condition of concrete steps at the south elevation.

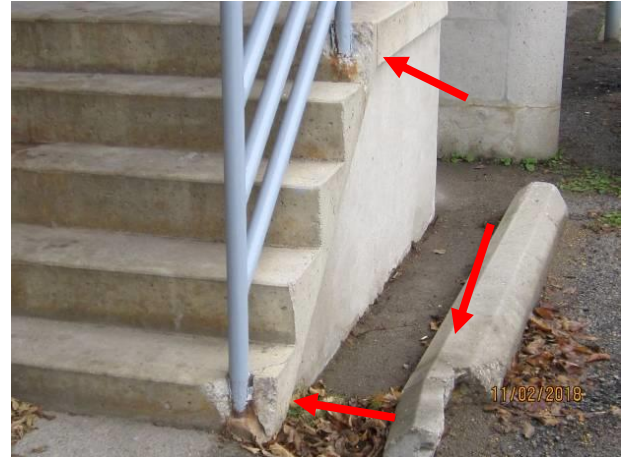
View showing chipped concrete at the connection of the handrail on the exterior stairs and broken wheel stops.

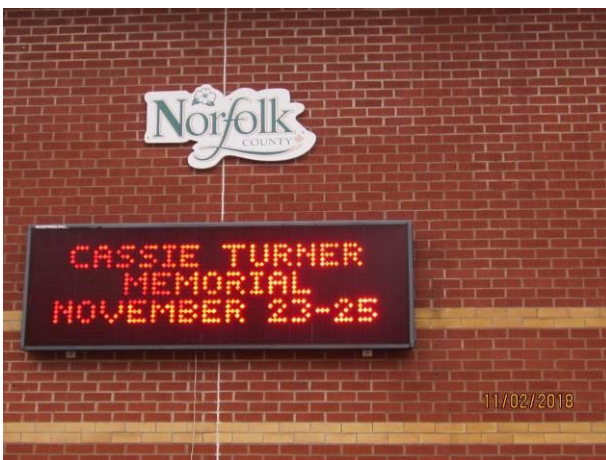
View showing the condition of the wall mounted building's main sign.

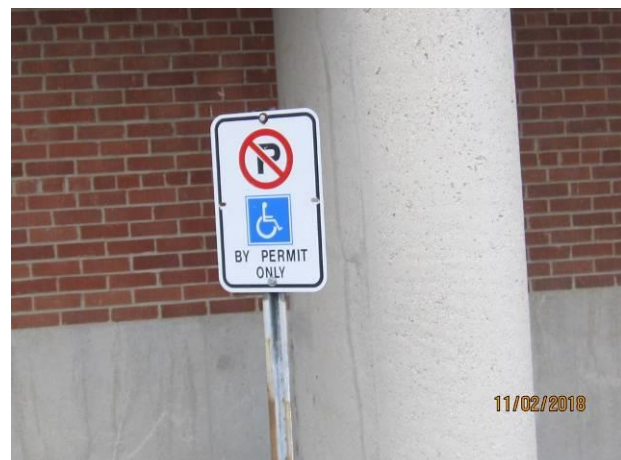
View showing the condition of the site signs in the parking lot area.

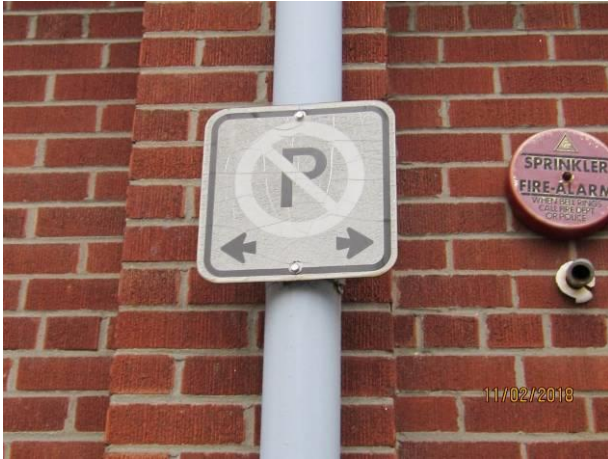
View showing the condition of faded parking sign.

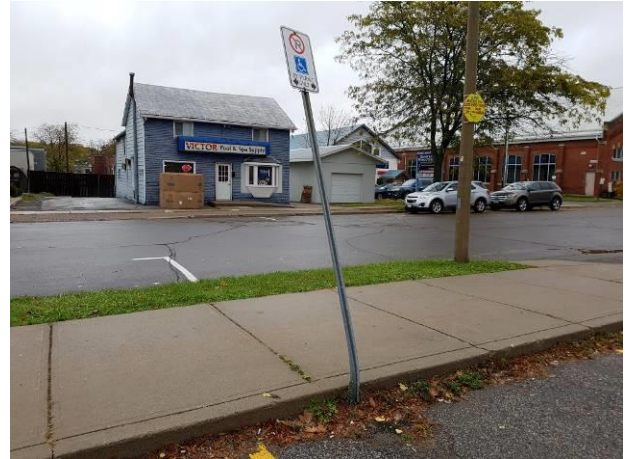
View showing tilted site sign for parking spaces.

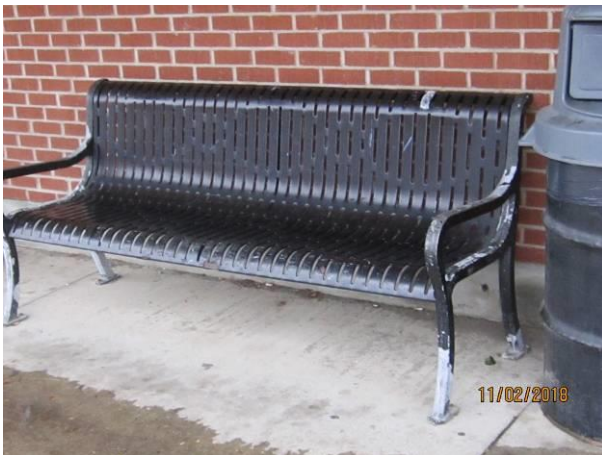
View showing the condition of the metal bench near the main entrance.

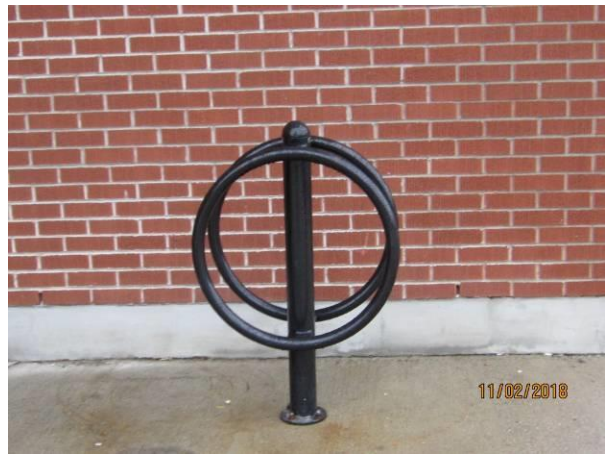
View showing the condition of the bicycle rack located near the main entrance.

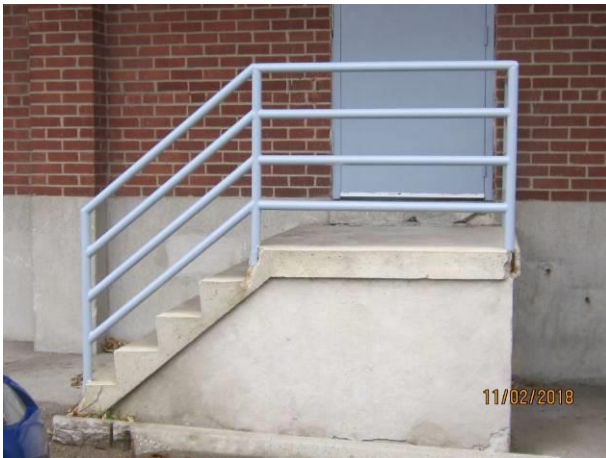
View showing the condition of the metal handrails on the exterior stairs.

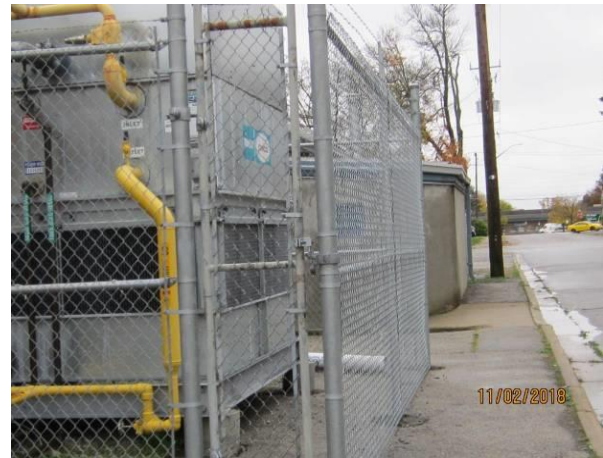
View showing the condition of the chain-link enclosure at the rear elevation around mechanical units.

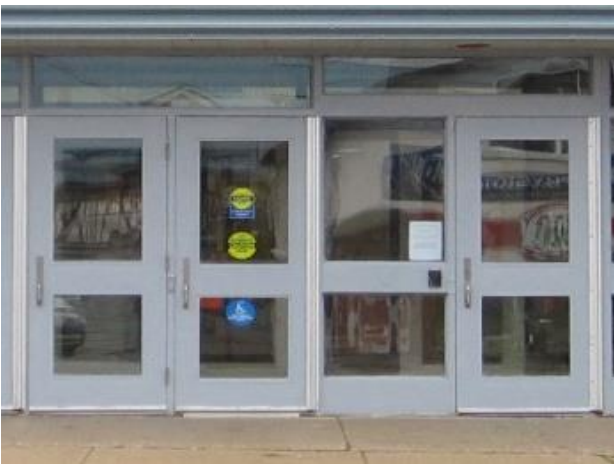
View showing the condition of the main entrance door.

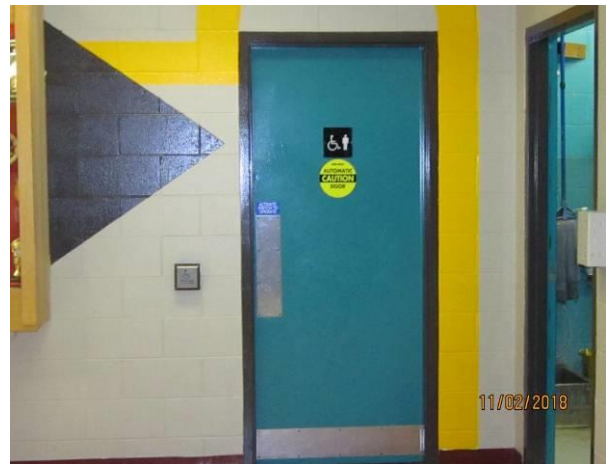
View showing the condition of the accessible washroom.

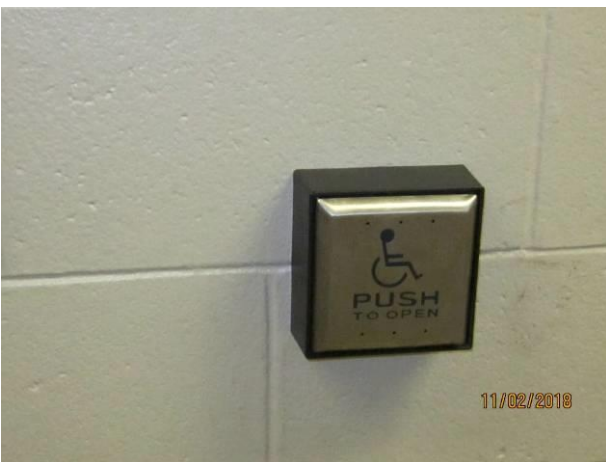
View showing the automatic door opener inside the building.

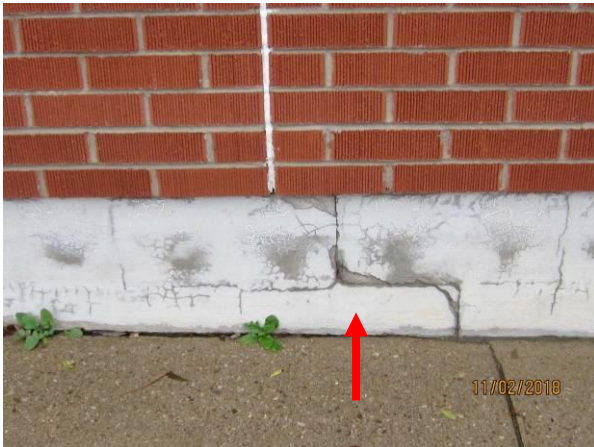
View showing cracks in foundation walls above grade.

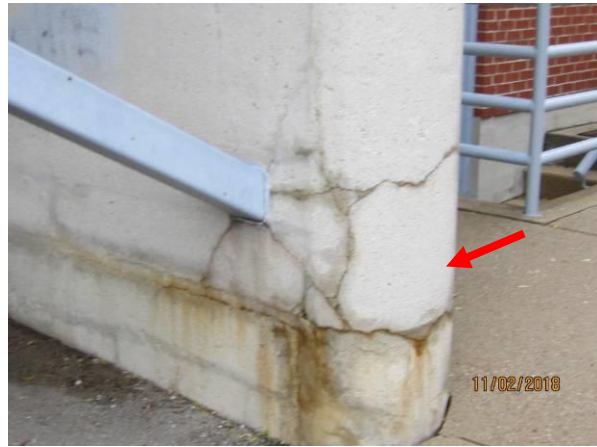
View showing cracked shear walls at the south elevation.

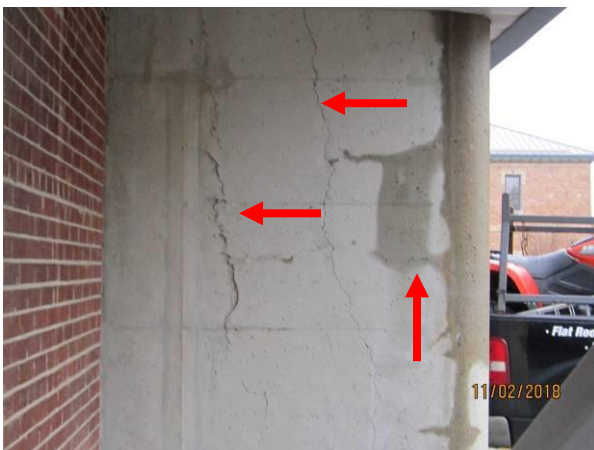
View showing cracked shear walls at the south elevation.

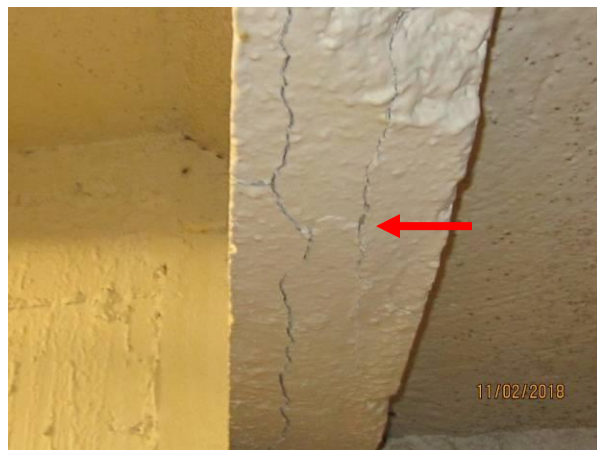
View showing cracks in the concrete beam in the ground level.

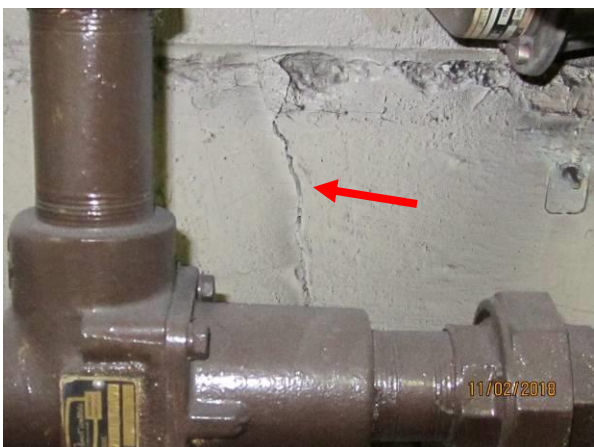
View showing vertical cracks in foundation walls in the service area.

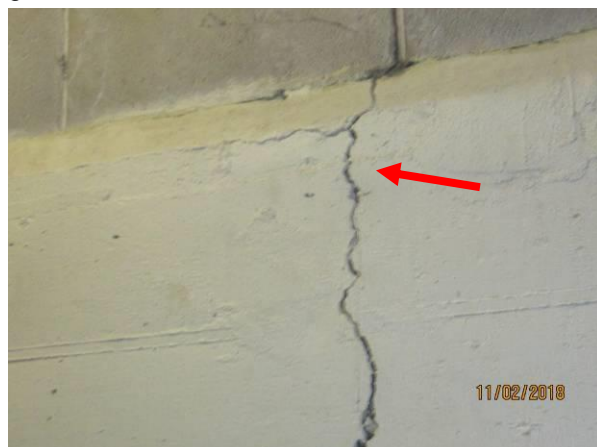
View showing vertical cracks in foundation walls in the service area.

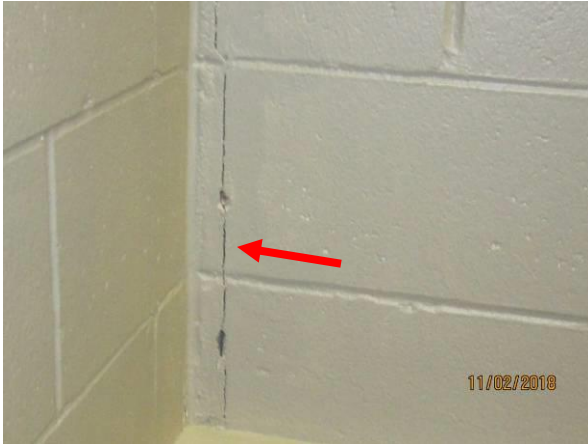
View showing vertical crack in concrete block walls.

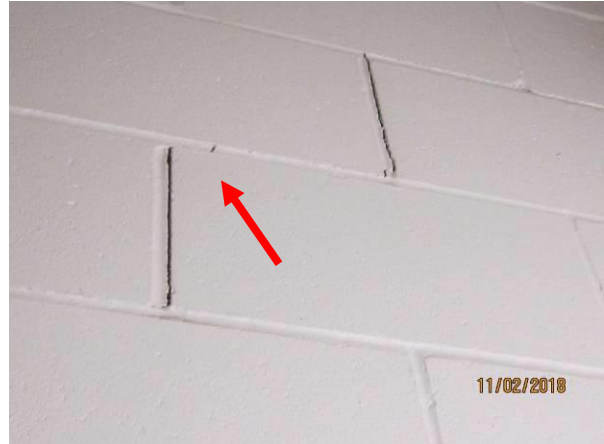
View showing step crack in concrete block walls at stair well leading to music room – third floor.

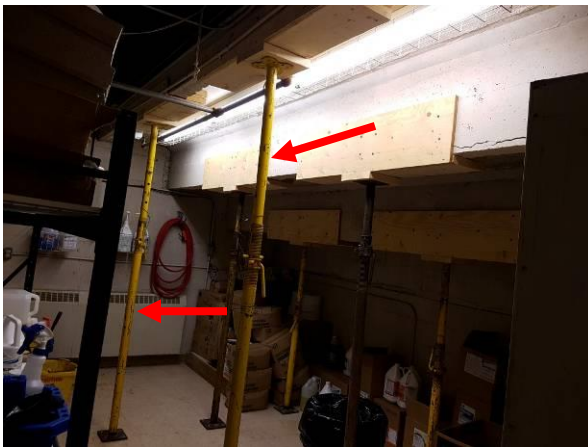
View showing metal posts supporting cracked concrete beams.

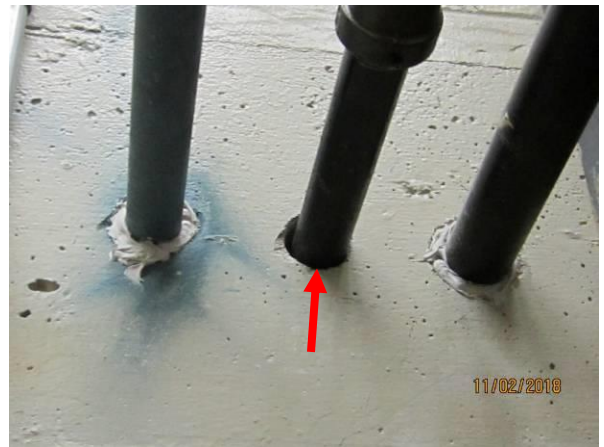
View showing missing smoke and firestopping around pipes penetrating concrete walls.

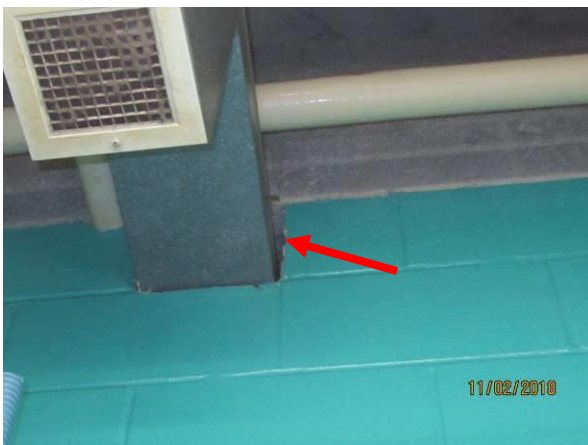
View showing missing smoke and firestopping around duct in concrete block walls

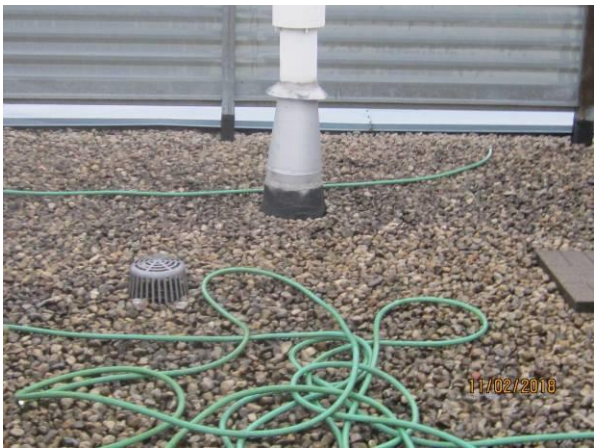
View showing the overall condition of the flat roof.

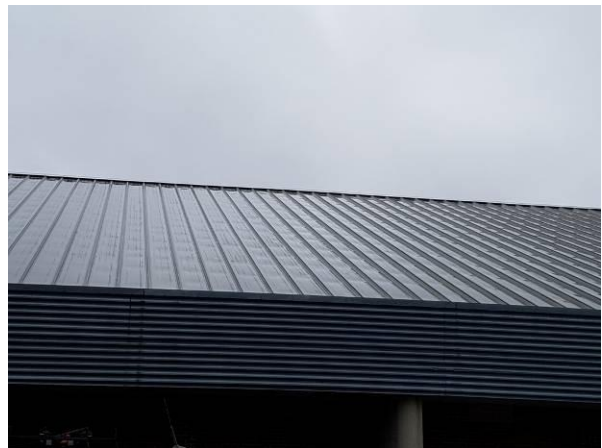
View showing the overall condition of the sloped metal roof.

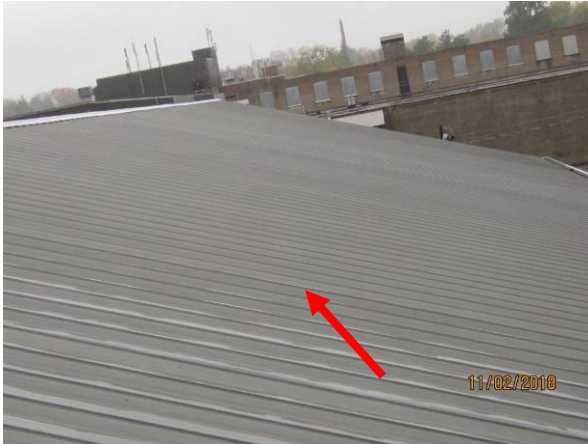
View showing the overall condition of the sloped metal roof.

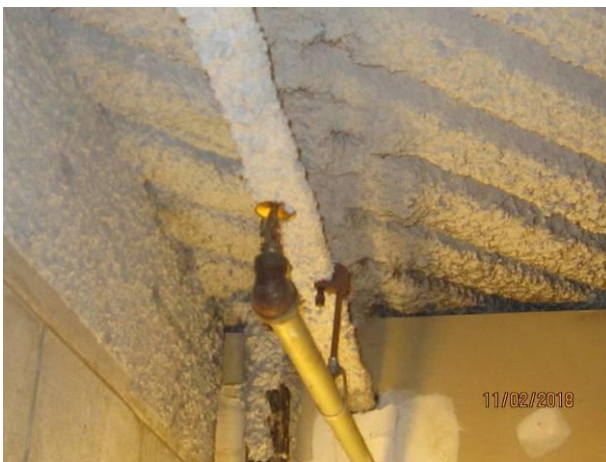
View showing the condition of the metal deck at the office building.

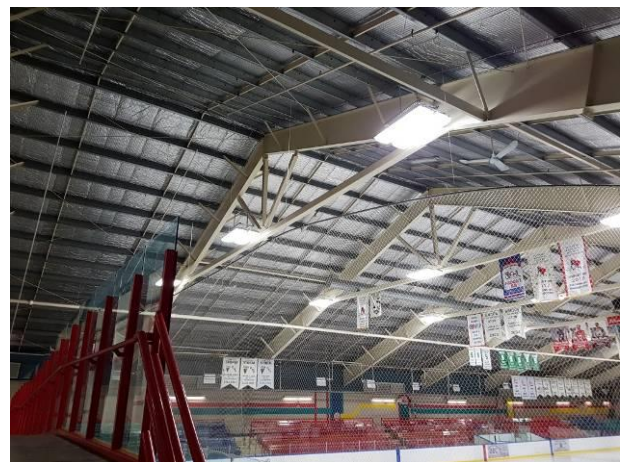
View showing the condition of the faced insulation supported by metal structure in the Arena.

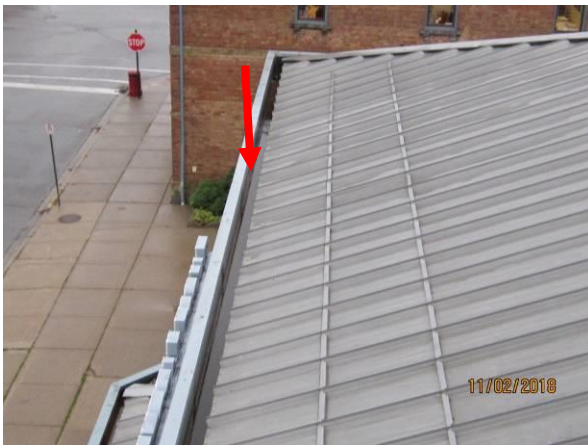
View showing the condition of the gutter at the edge of the sloped metal roof.

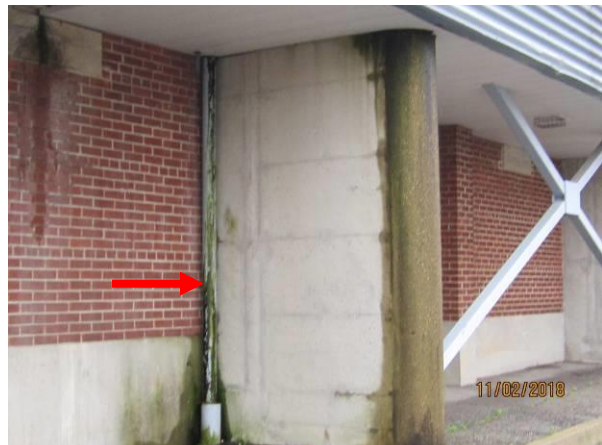
View showing the condition of the broken downspout at the north elevation.

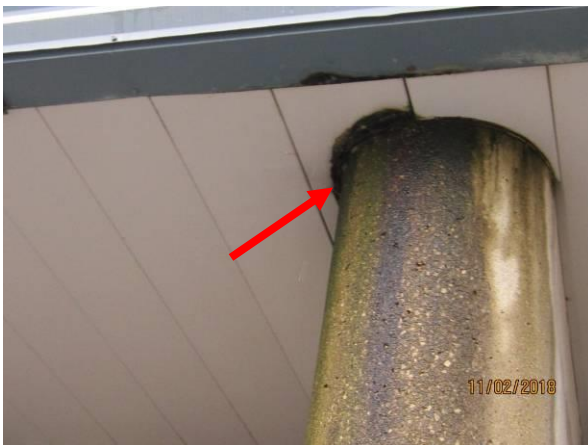
View showing the condition of the metal soffit and draining water around the concrete column.

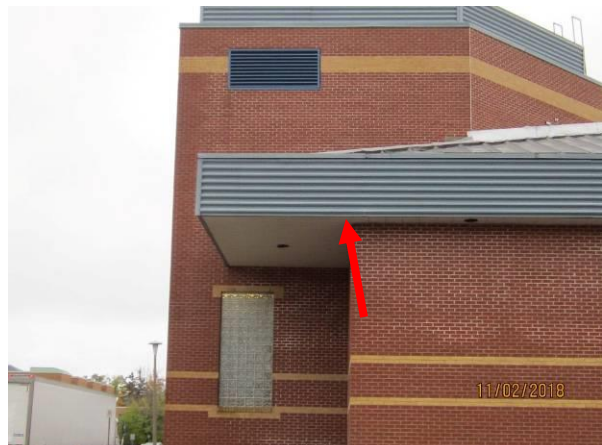
View showing the condition of the metal soffit and fascia.

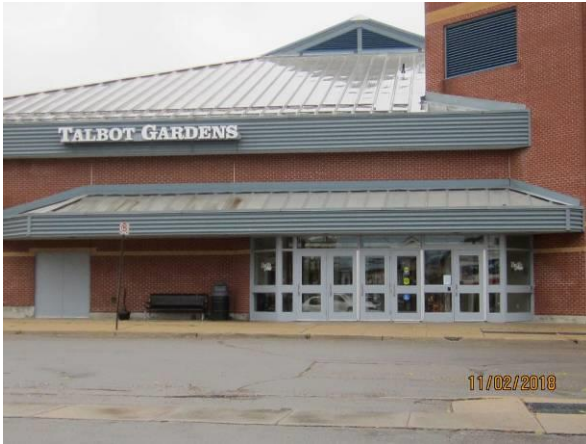
View showing the condition of the front canopy above the main entrance.

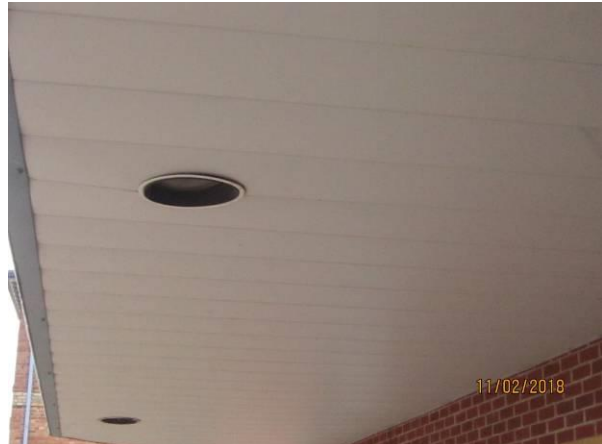
View showing the condition of the front canopy's soffit.

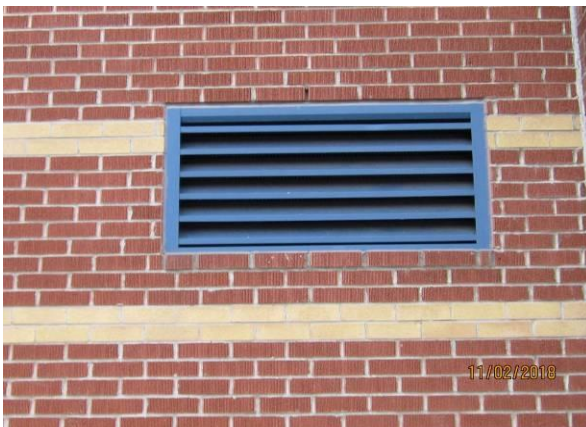
View showing the condition of the vent cover on the exterior walls.

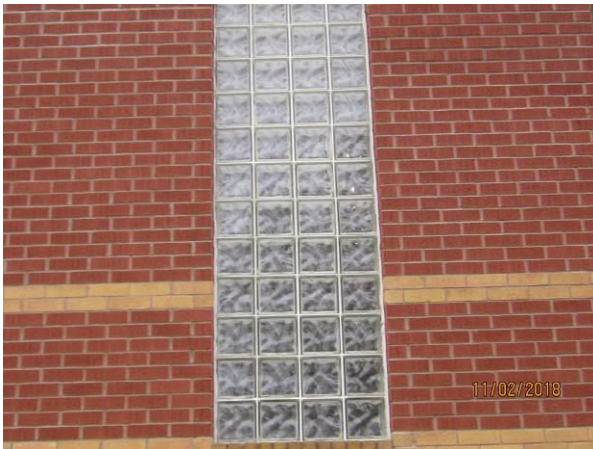
View showing the condition of the brick veneer.

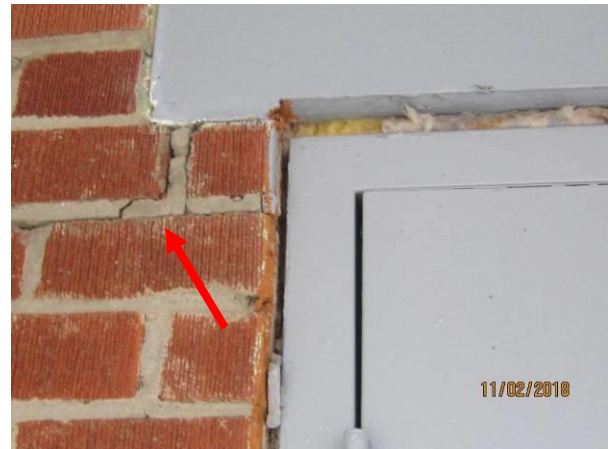
View showing cracked mortar joints in the brick veneer near exterior door at the south elevation.

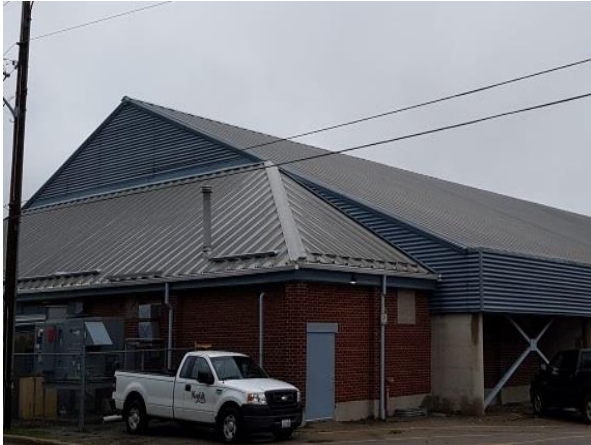
View showing the metal cladding at the building perimeter and gables.

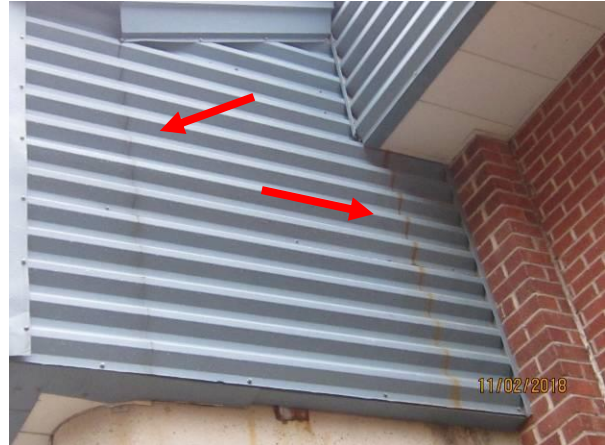
View showing rust stains on the metal cladding at the south elevation

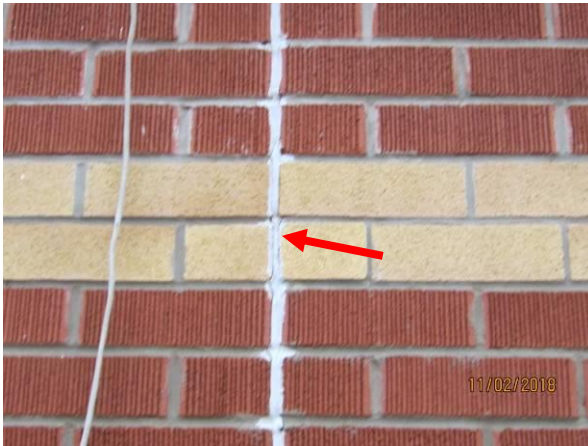
View showing damaged sealant for wall joints in the brick cladding.

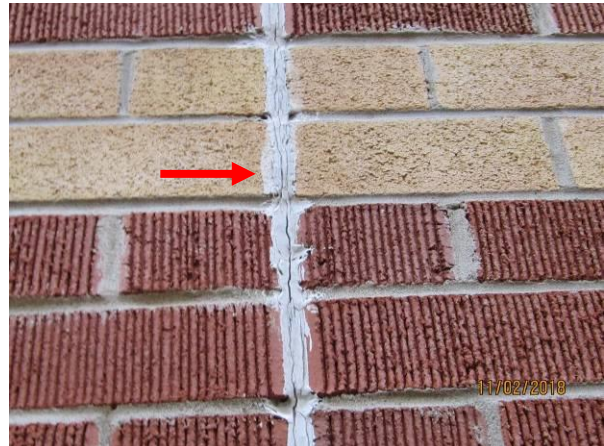
View showing close up view of the previous photograph.

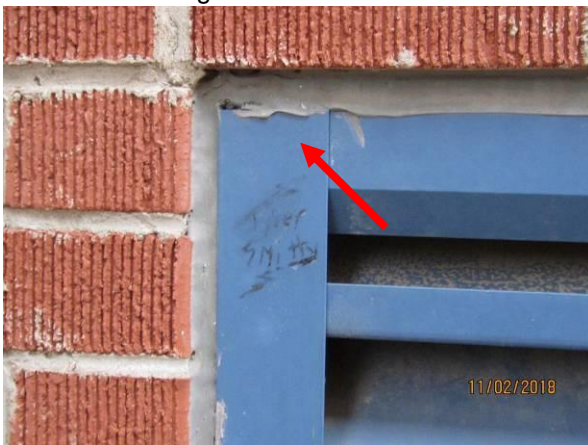
View showing damaged sealant around exterior louver.

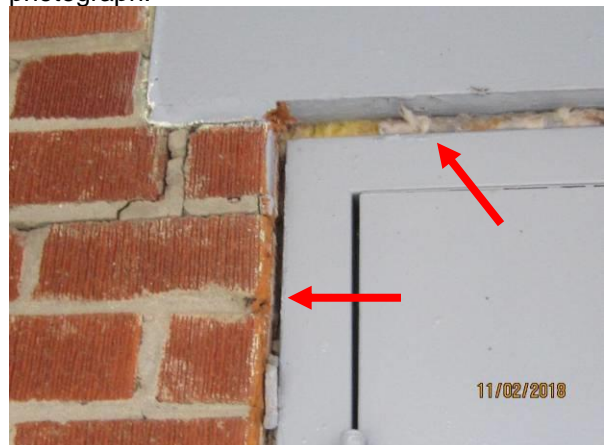
View showing missing sealant around door frame at the south elevation.

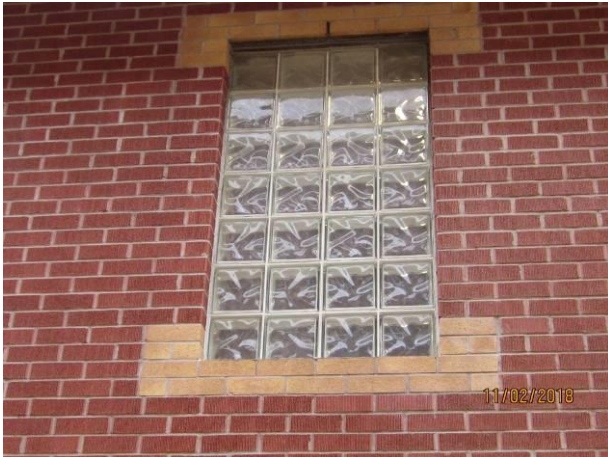
View showing typical condition of the exterior window assembly.

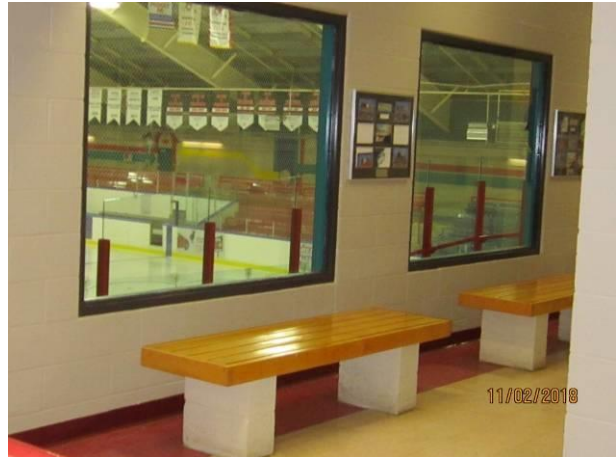
View showing typical condition of the interior window assembly.

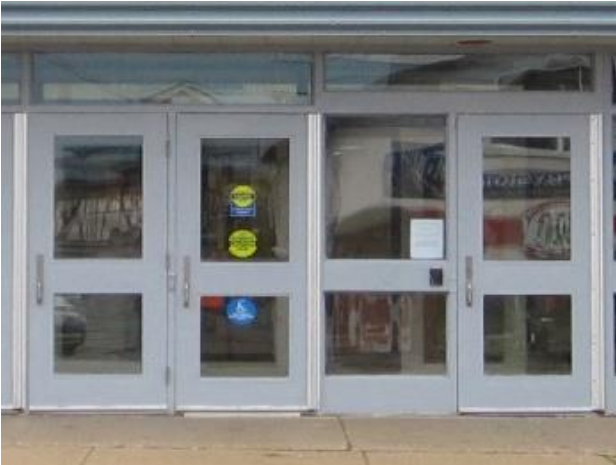
View showing the condition of the main entrance.

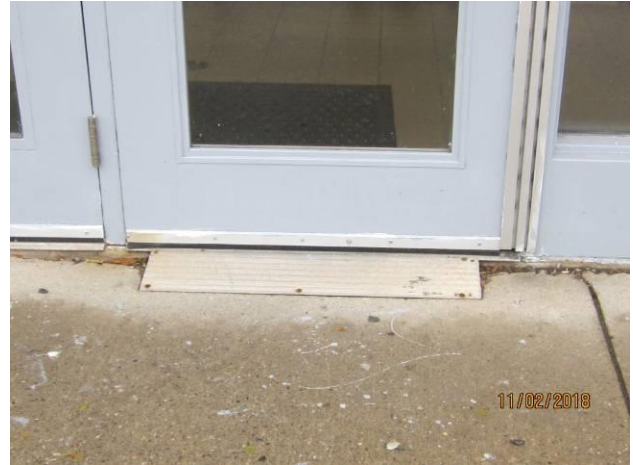
View showing a small ramp at the front entrance door (accessible door).

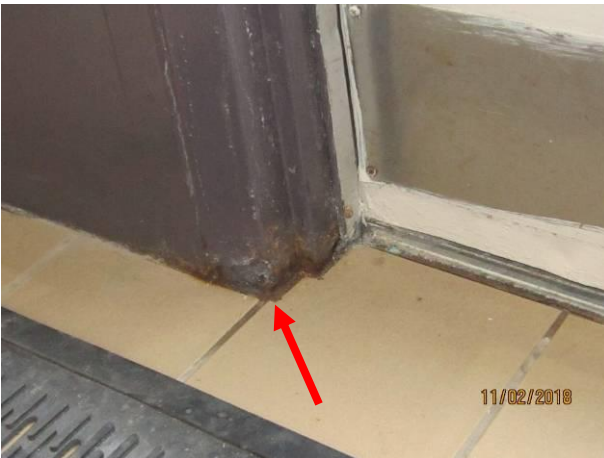
View showing corroded metal frame at the entrance door.

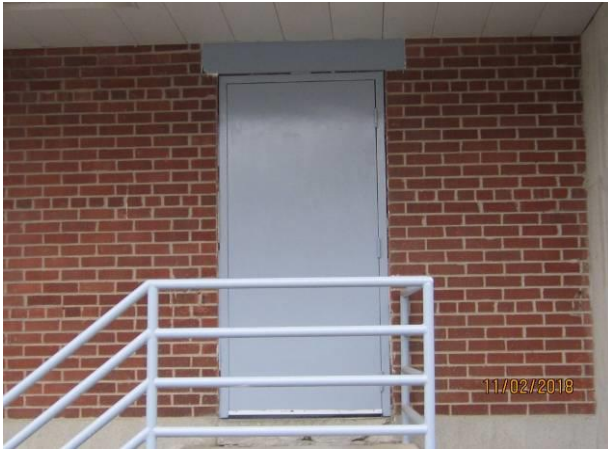
View showing the condition of the exterior single leaf door.

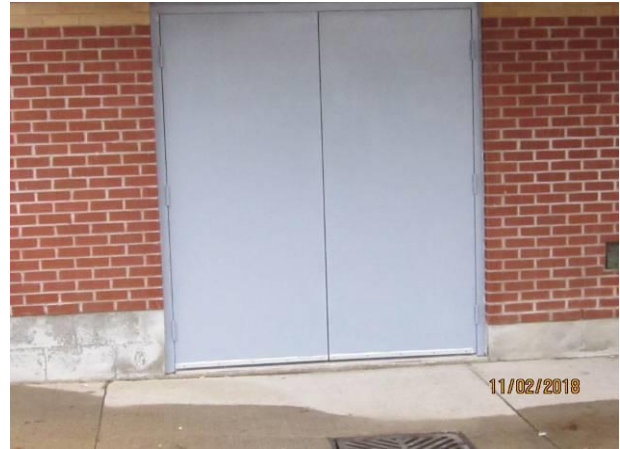
View showing the condition of the metal service double door.

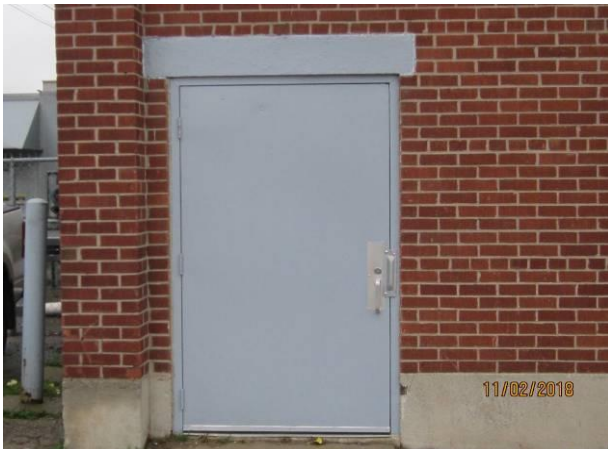
View showing overall condition of the metal single service door.

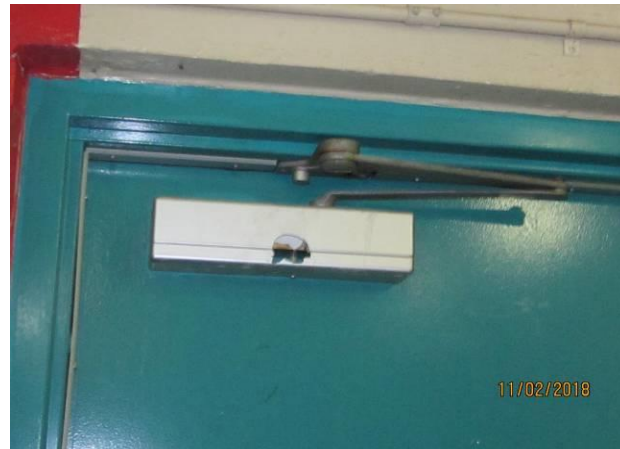
View showing the condition of the auto closer for exit and service doors.

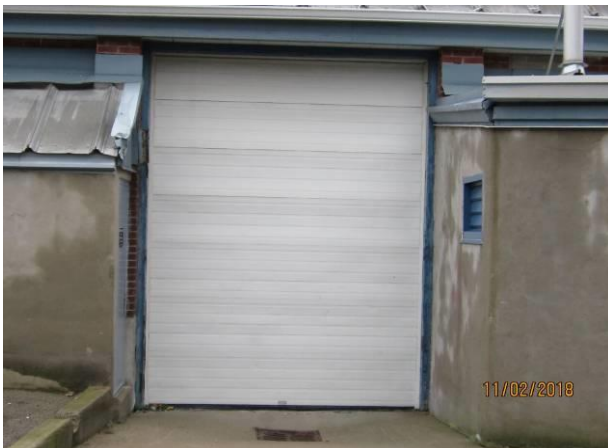
View showing the condition of the overhead door at the west elevation.

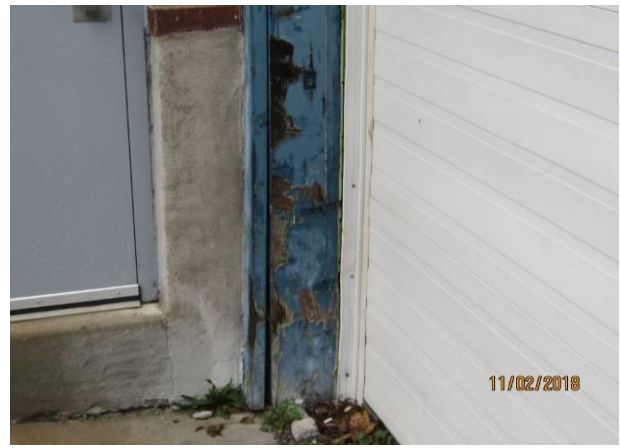
View showing rotten wood frame for overhead door.

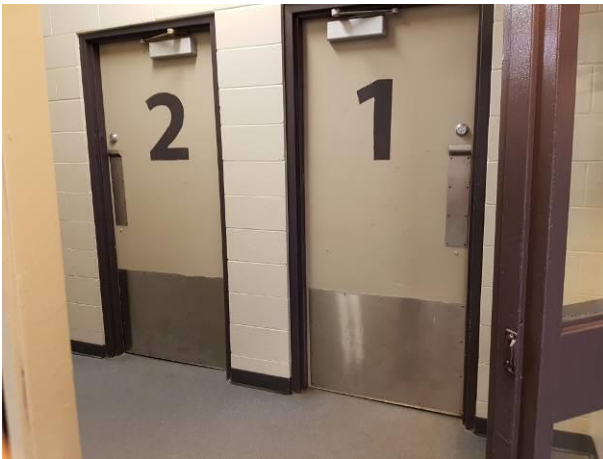
View showing the condition of the interior single metal doors for change rooms.

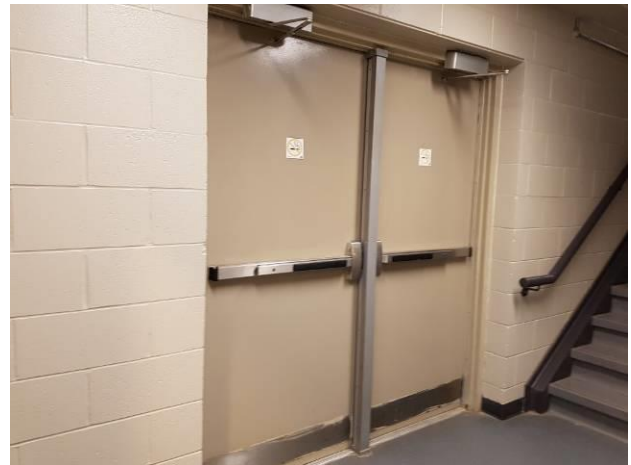
View showing the condition of the interior double doors.

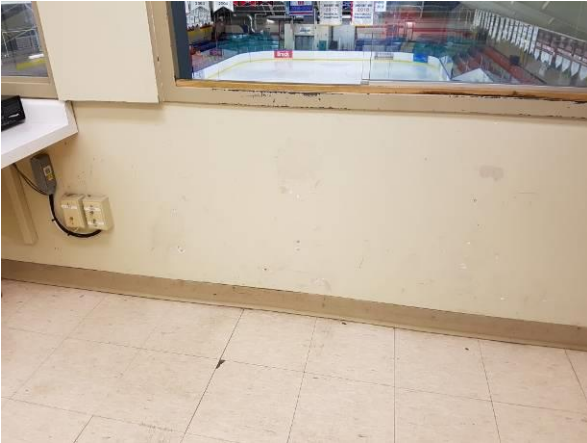
View showing the condition of the drywall in the third floor.

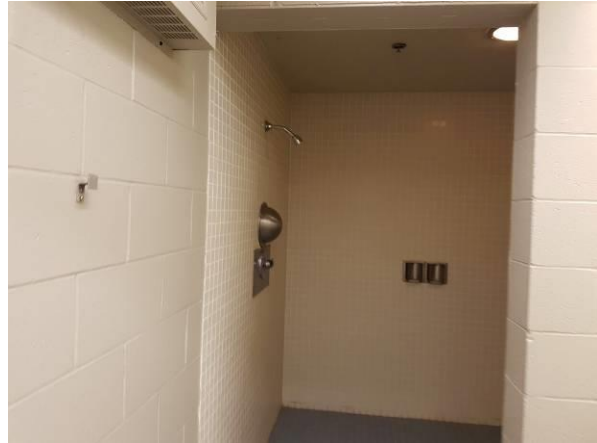
View showing the condition of the ceramic wall tiles in the shower area and painted block walls in the change rooms

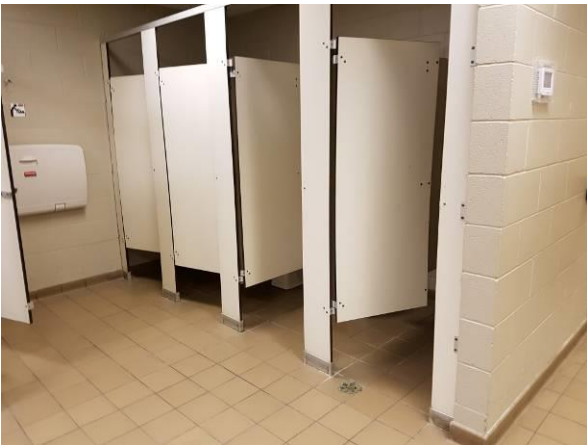
View showing the condition of the partition walls in the washroom area.

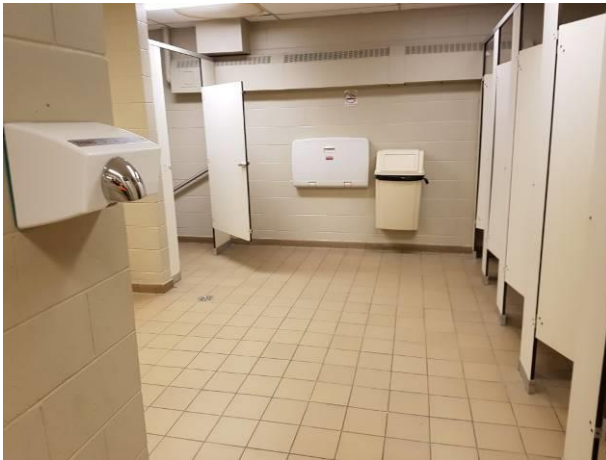
View showing the condition of the ceramic tiles in the washrooms.

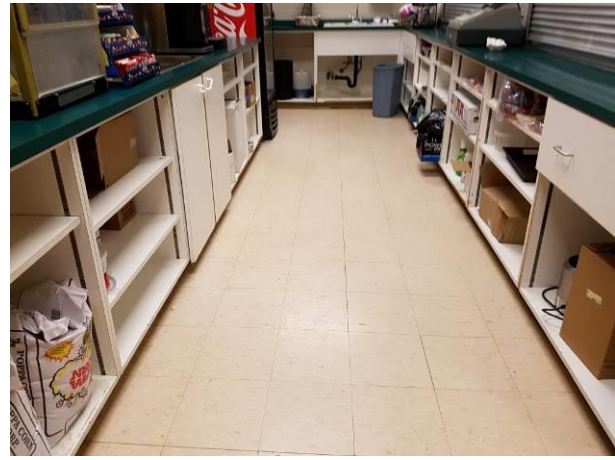
View showing overall condition of the vinyl flooring in Concession Room.

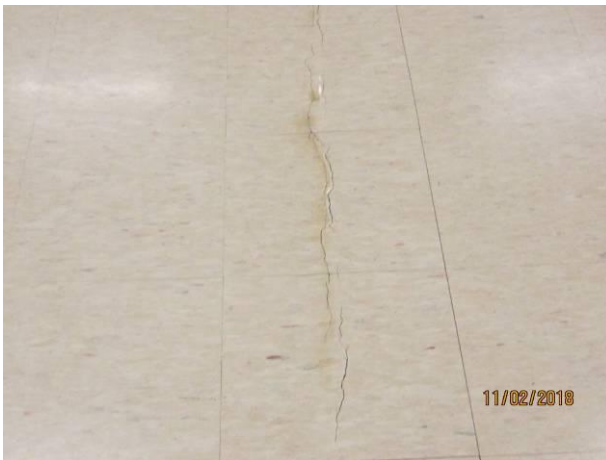
View showing cracked vinyl floor in the hallway second floor.

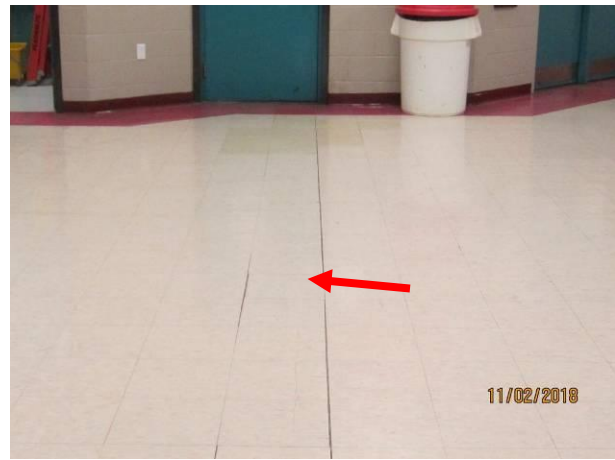
View showing gaps/separation in vinyl flooring.

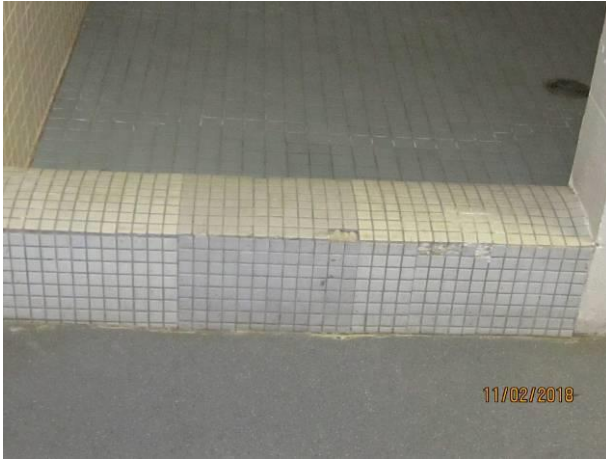
View showing the condition of the ceramic tiles in the shower area.

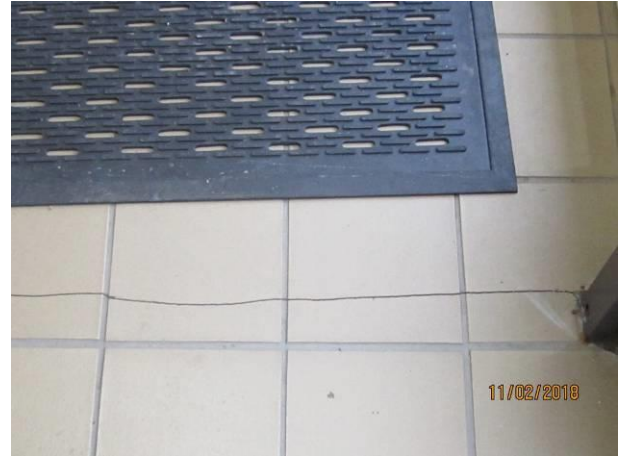
View showing cracked ceramic tiles in the vestibule area.

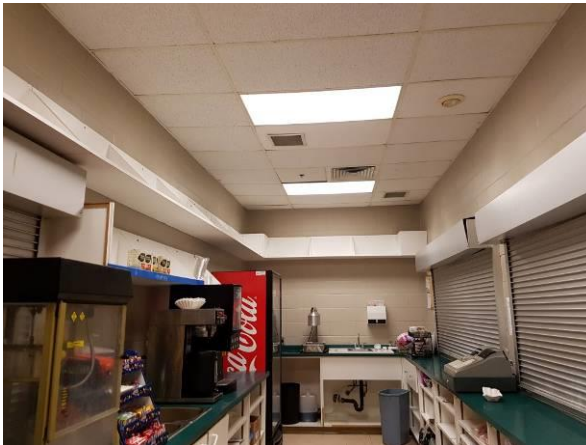
View showing overall condition of the drop down ceiling.

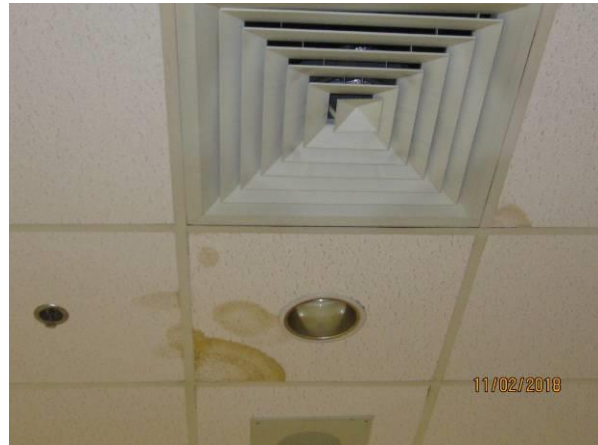
View showing typical stains on ceiling tiles.

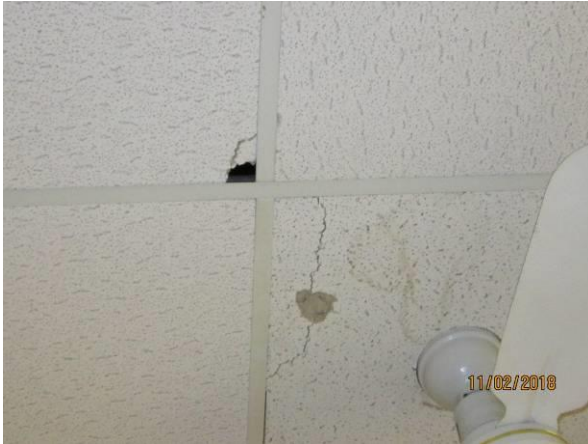
View showing a broken ceiling tile in the storage area.
