**BUILDING CONDITION ASSESSMENT
10 TALBOT STREET NORTH
SIMCOE, ONTARIO
for
NORFOLK COUNTY**

PETO MacCALLUM LTD.
45 BURFORD ROAD
HAMILTON, ONTARIO
L8E 3C6
Phone: (905) 561-2231
Fax: (905) 561-6366
Email: hamilton@petomacallum.com

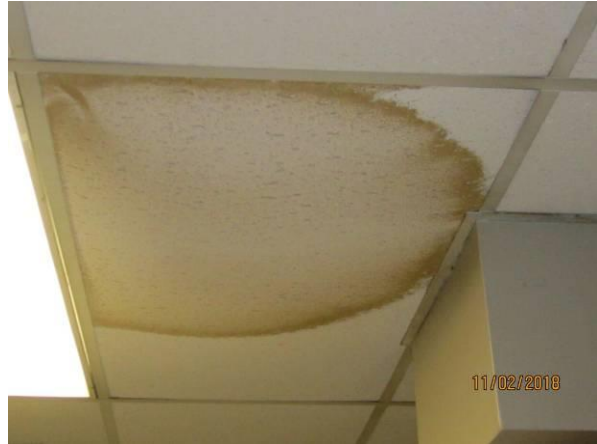
View showing stains on ceiling tiles in the women's washroom.

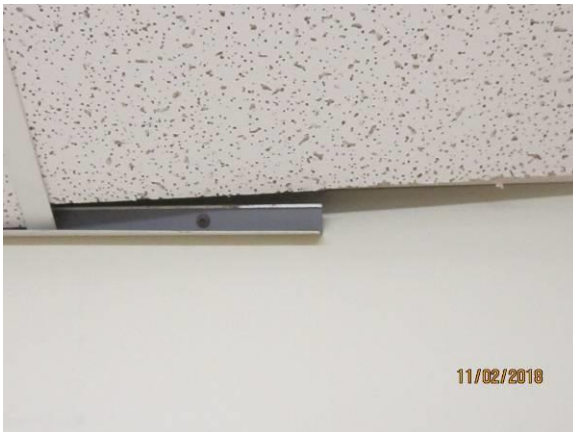
View showing broken tile frame in the third floor.

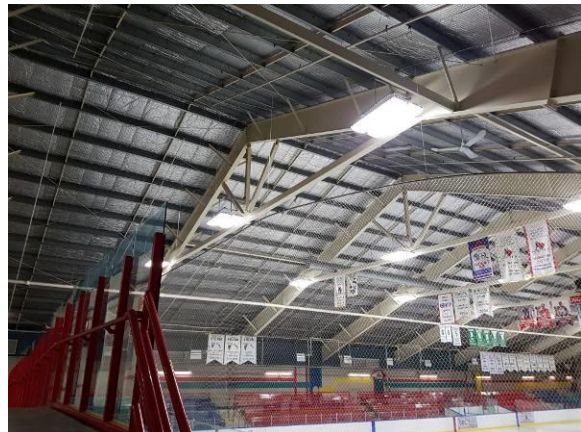
View showing overall condition of the insulation ceiling in the Arena.

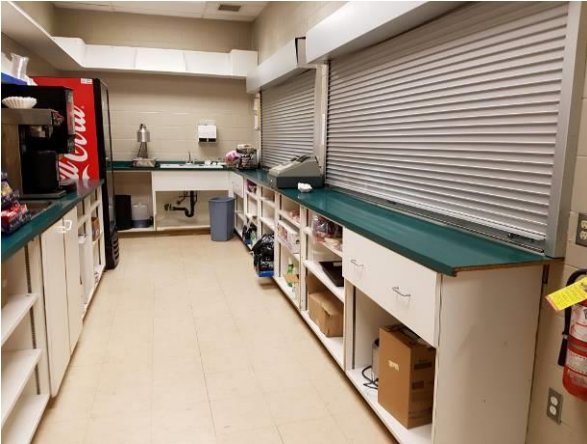
View showing the cabinetry and countertop in the service areas in second floor.

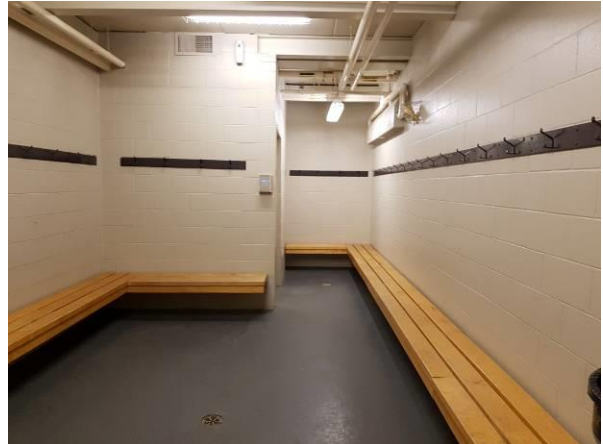
View showing the condition of the wood seats in the change rooms.

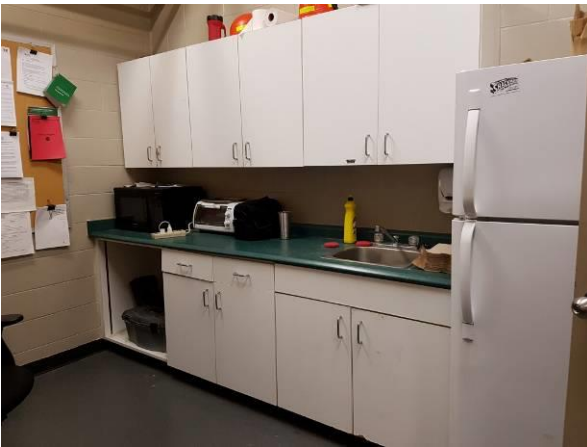
View showing the condition of the cabinets in the ground floor near main office.

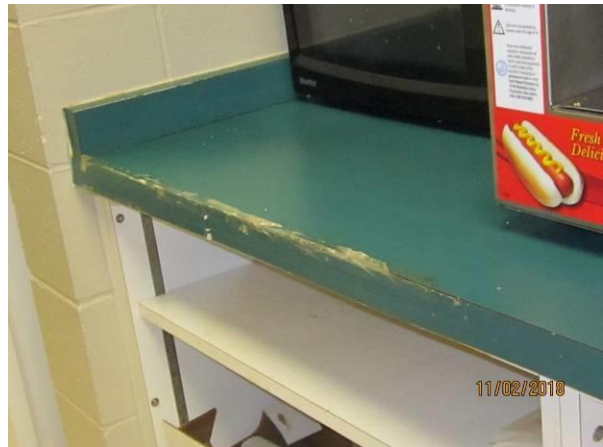
View showing damaged countertop in the Concession Room.

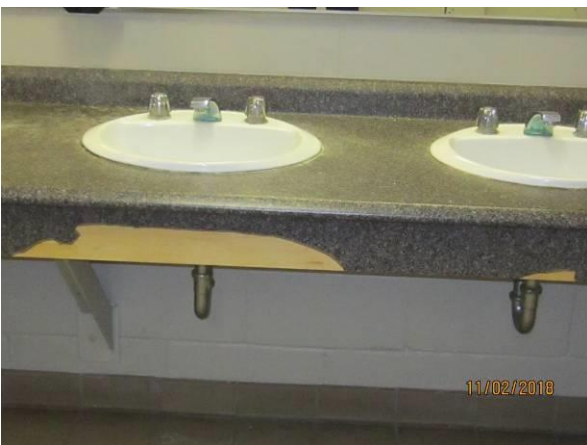
View showing damaged countertop in the women's washroom.

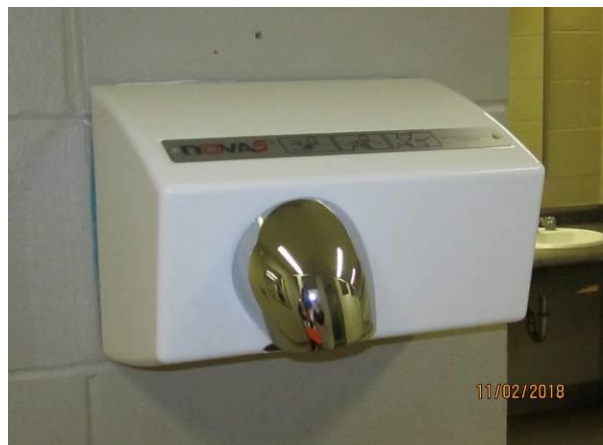
View showing the condition of the hand dryer in the washrooms.

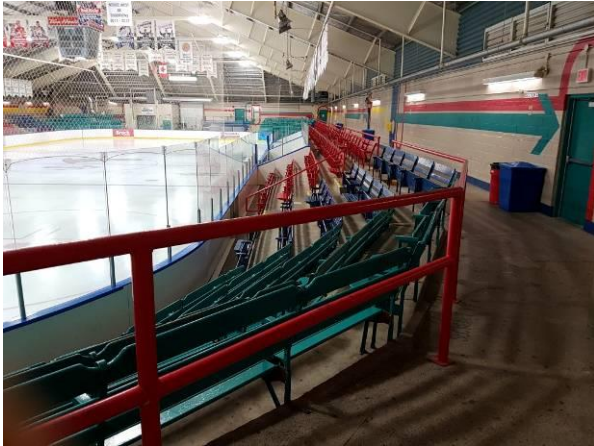
View showing overall condition of the seats in the Arena.

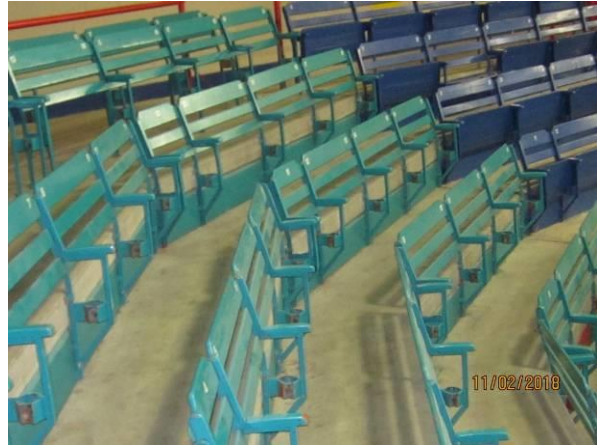
View showing damaged/missing wood seats in the Arena.

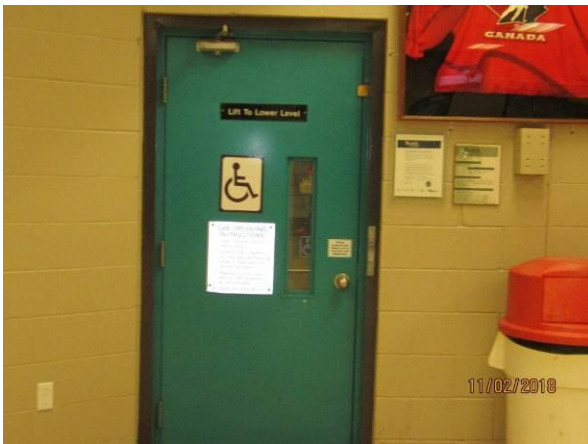
View showing the elevator door at the second floor

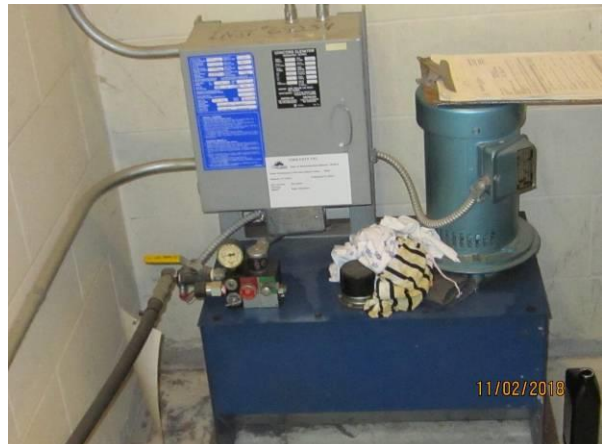
View showing the condition of the elevator machine in the ground floor.

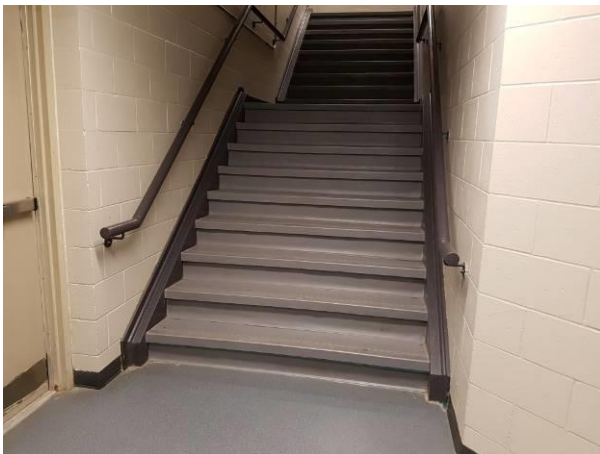
View showing the condition of the stairs with metal handrail.

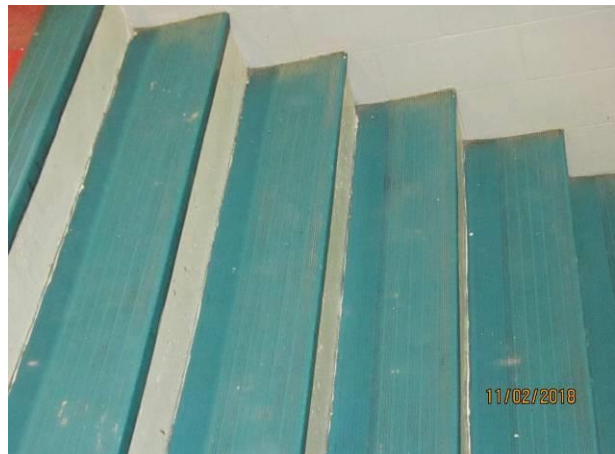
View showing the condition of the stair's cover at the east side of the building.

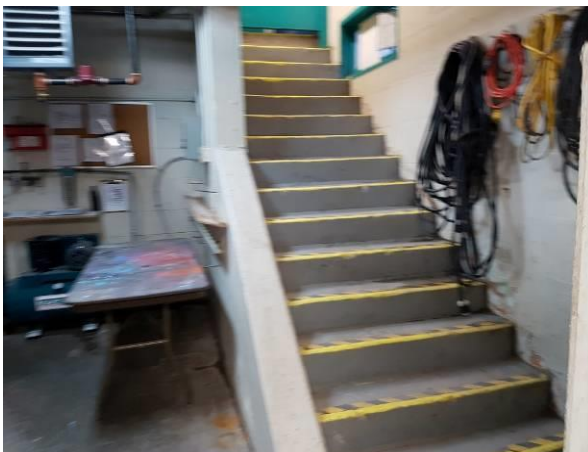
View showing the condition of concrete stairs in the mechanical/sprinkler room with no handrail.

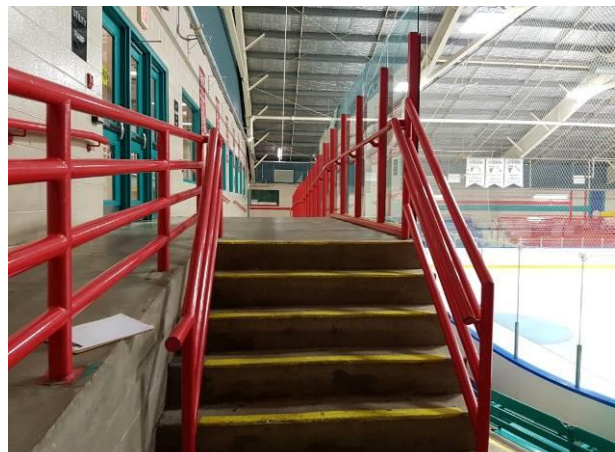
View showing the condition of the stairs, metal handrails and the concrete ramp in the Arena area.

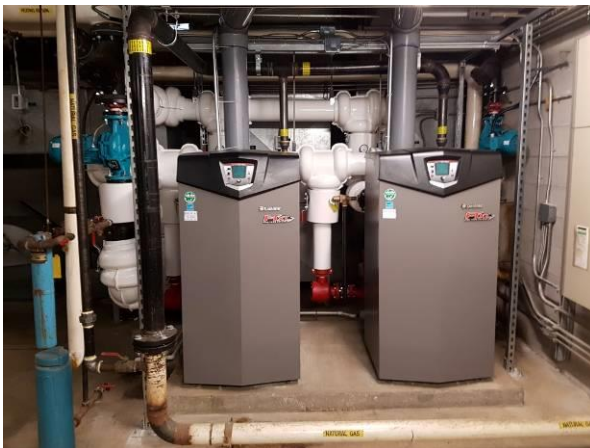
View showing the condition of the boilers in the penthouse.

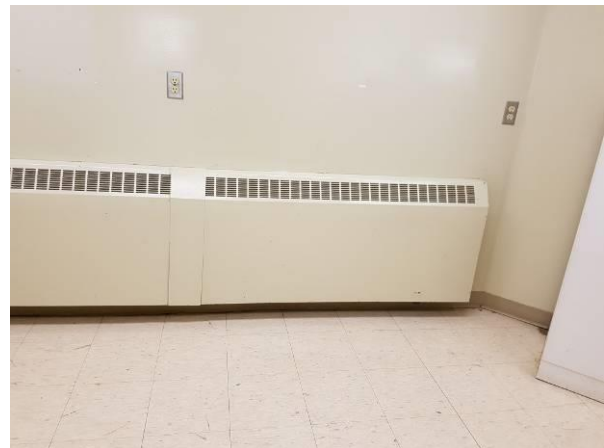
View showing typical condition of the baseboard heaters in the building.

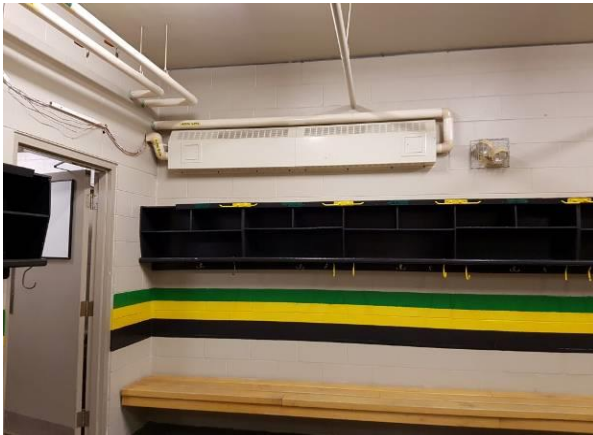
View showing the condition of the wall mounted heaters in the change rooms.

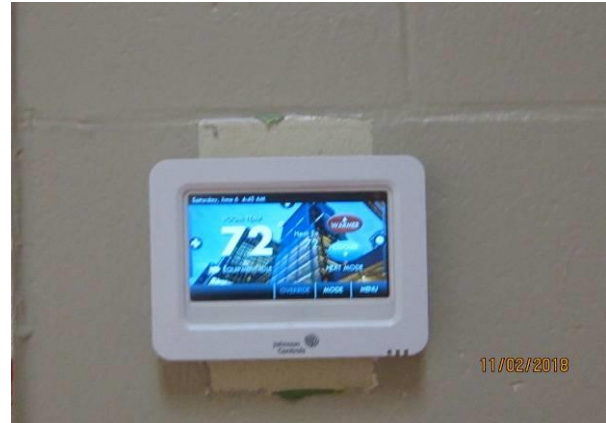
View showing the condition of the new thermostat in the building.

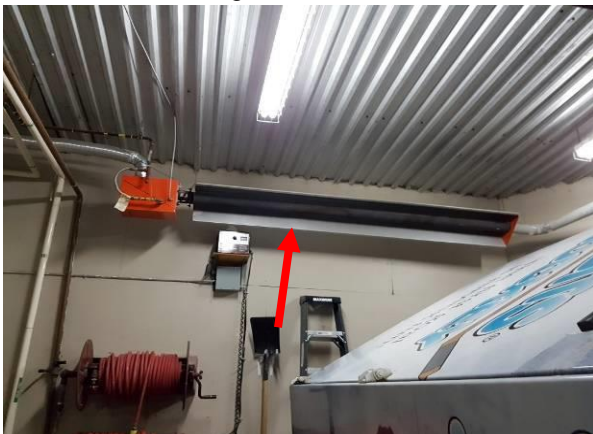
View showing the condition of the ceiling mounted heater in the zamboni room.

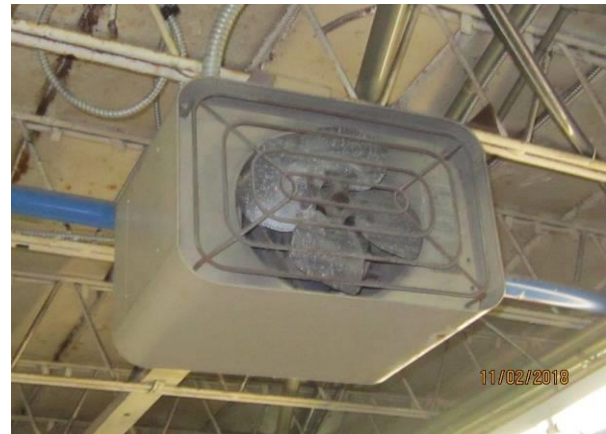
View showing the condition of the ceiling mounted heater in the refrigerator room.

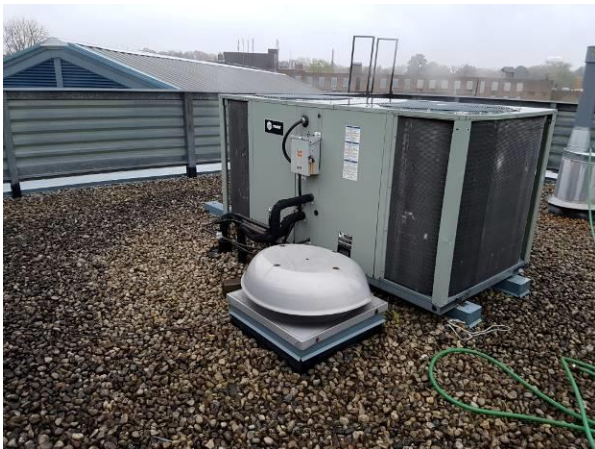
View showing the condition of the HVAC unit on the flat roof.

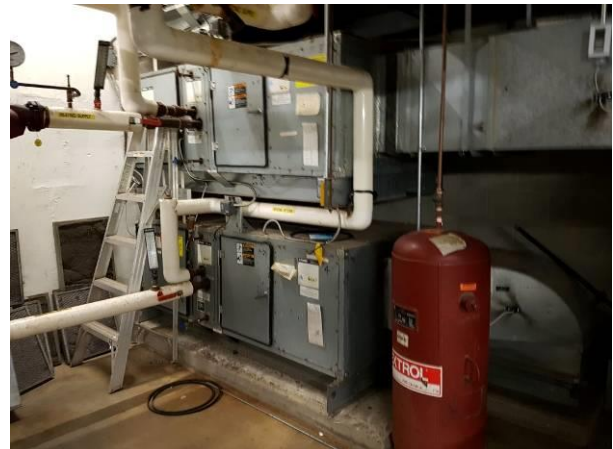
View showing the condition of two air handling units in the penthouse.

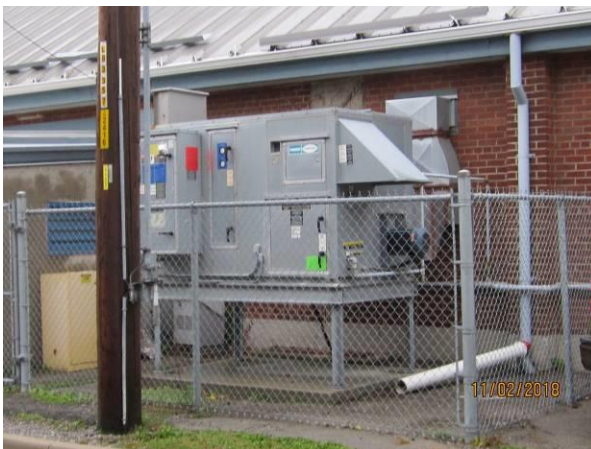
View showing the condition of the air-handling unit west side of the building.

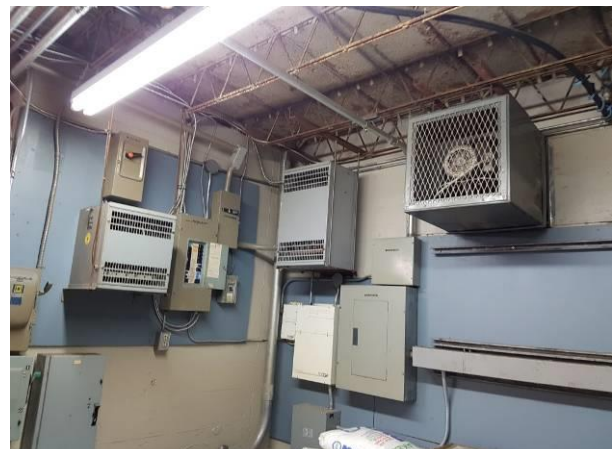
View showing the condition of the wall exhaust fan in the service room.

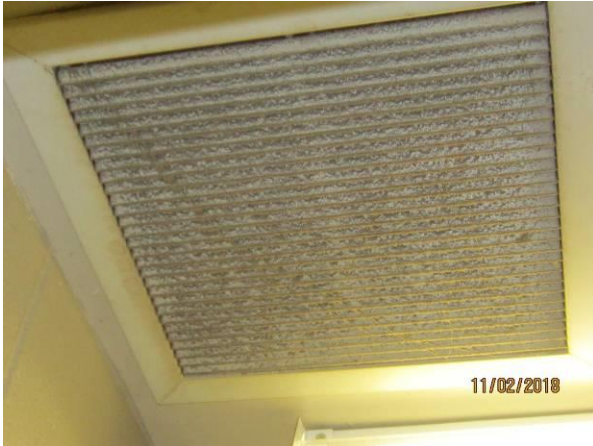
View showing the condition of the ceiling exhaust vent in the washrooms – change rooms.

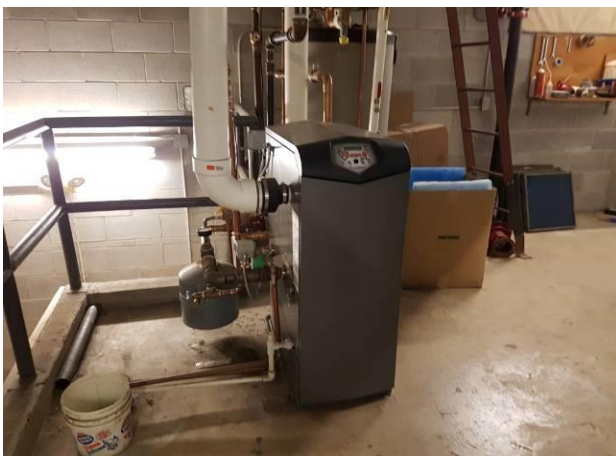
View showing the condition of the boiler in the penthouse.

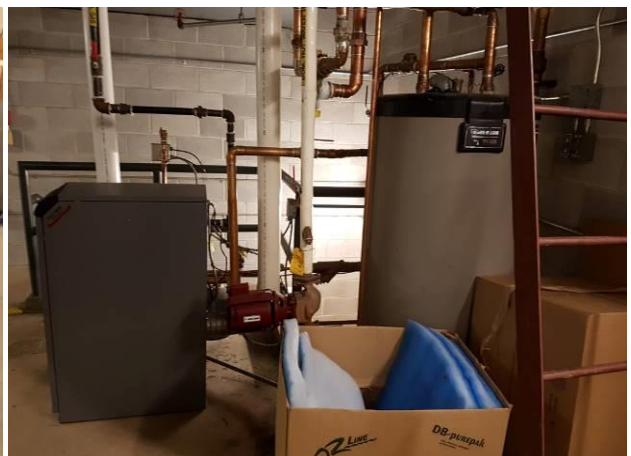
View showing the condition of the boiler and water tank in the penthouse.

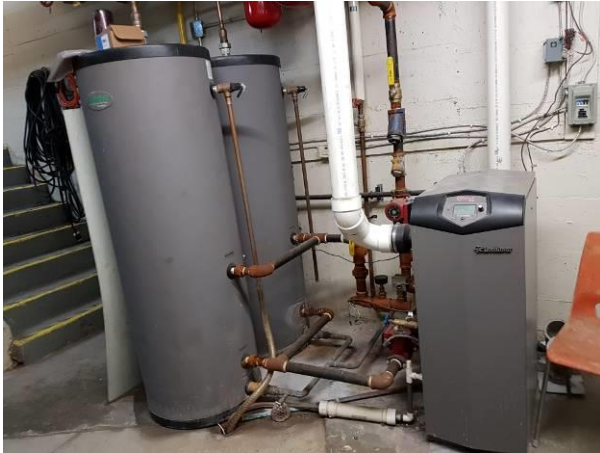
View showing the condition of the the boiler and water tanks in the sprinkler room.

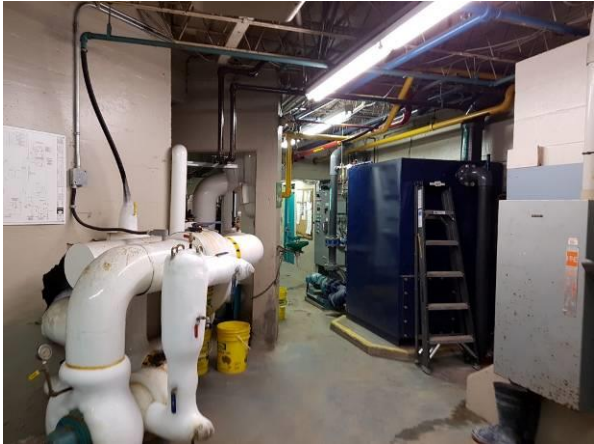
View showing overall condition of the refrigerator room.

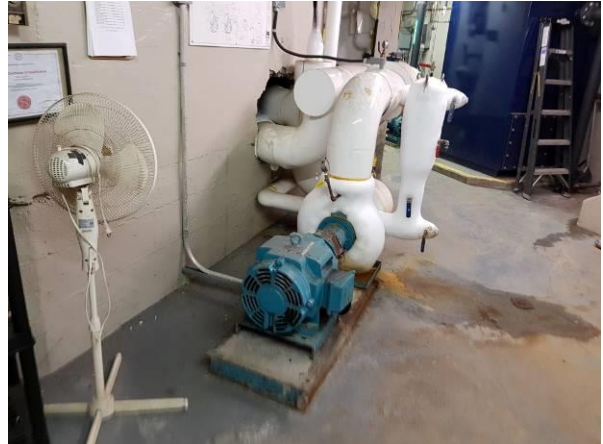
View showing the condition of the pipes and pumps in the refrigerator room.

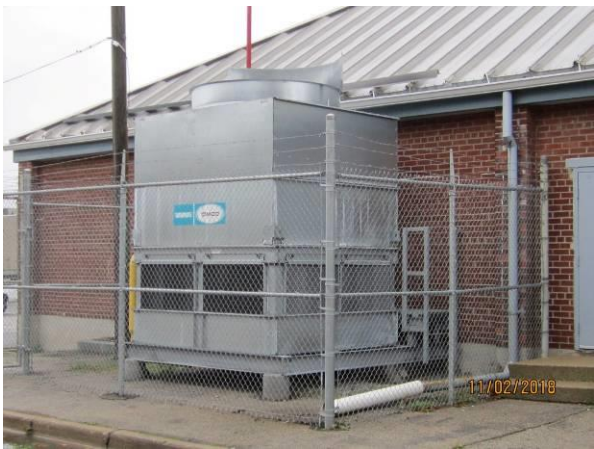
View showing the condition of the chiller unit west of the building.

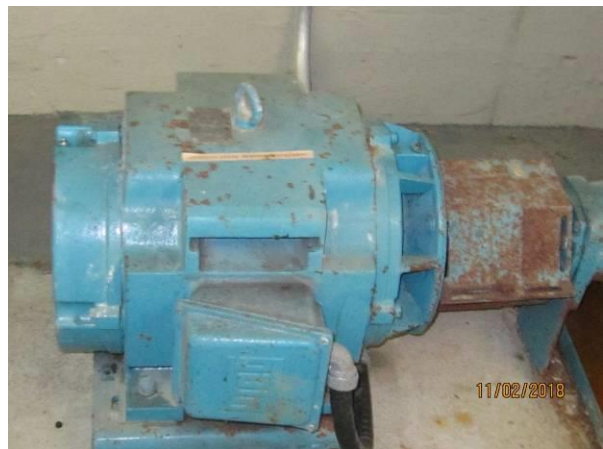
View showing signs of corrosion on the pumps.

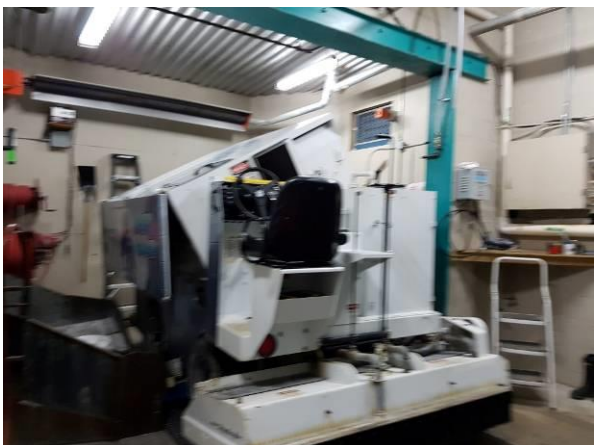
View showing the condition of the Zamboni.

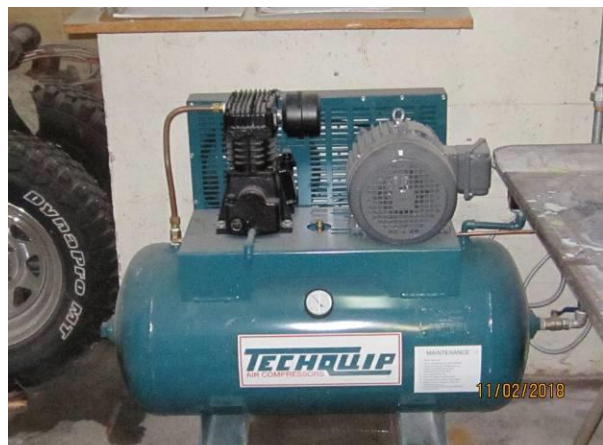
View showing the condition of the air compressor.

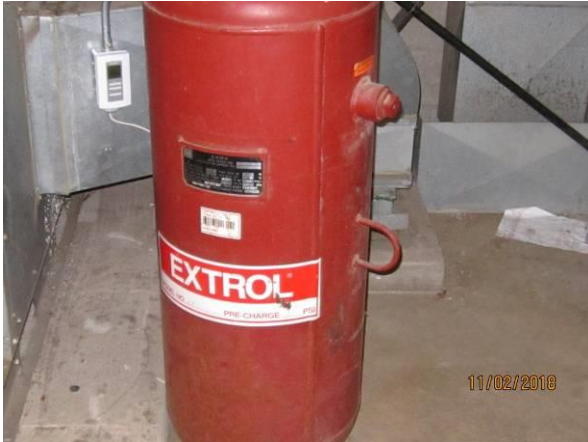
View showing the condition of the pressure tank in the penthouse.

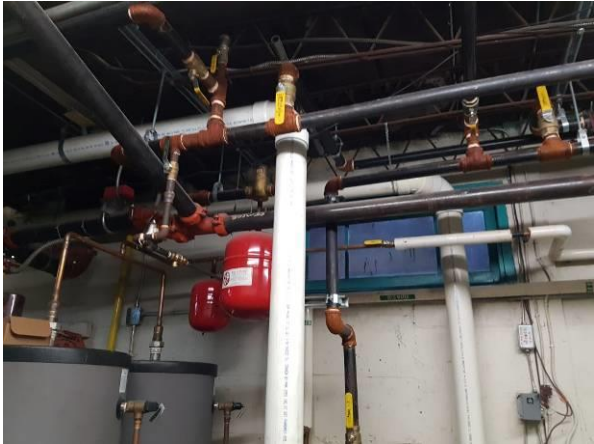
View showing the condition of the pipes and expansion tanks in the sprinkler room.

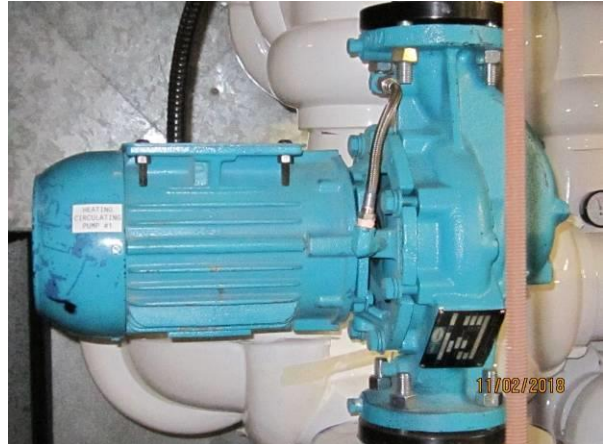
View showing the condition of the pumps.

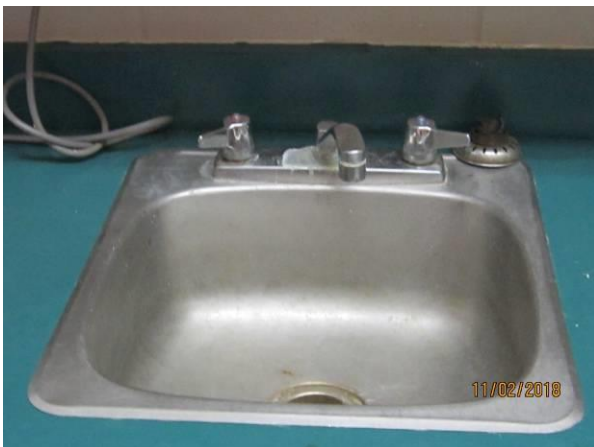
View showing the condition of the stainless steel sinks in service rooms.

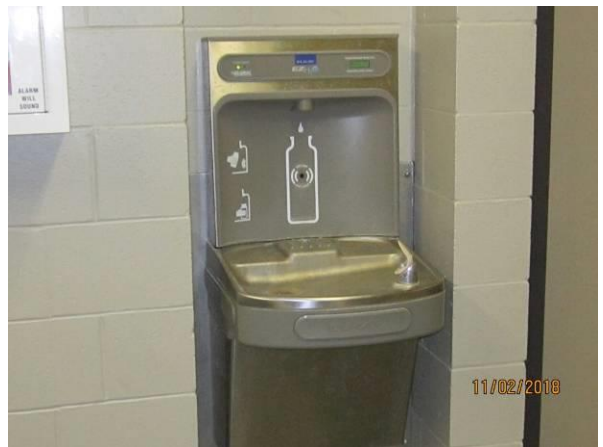
View showing the condition of the drinking fountain in the building.

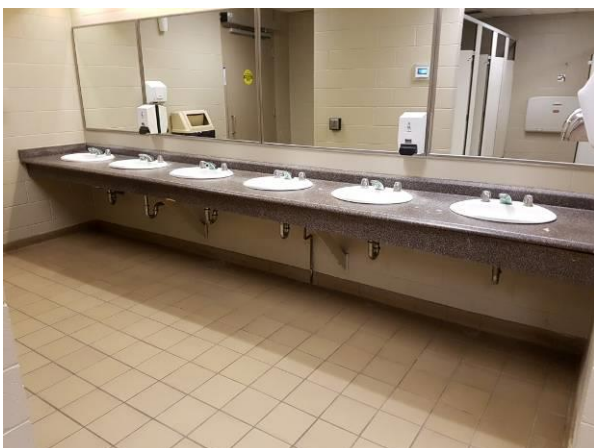
View showing the condition of the sinks and countertop in the washrooms.

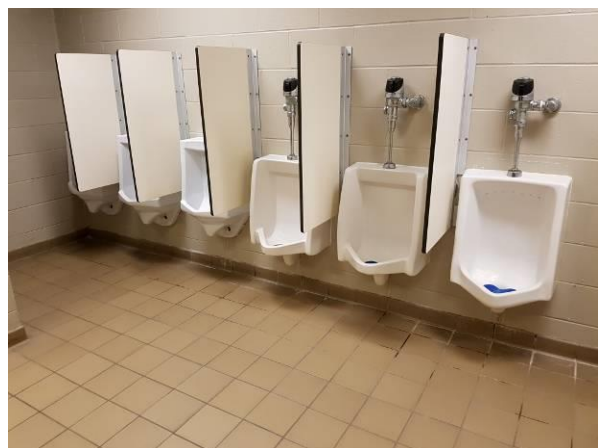
View showing the condition of the urinals in the washrooms.

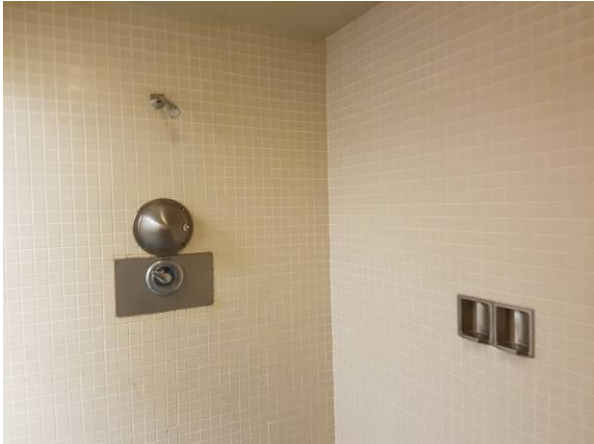
View showing the condition of plumbing fixtures in the shower area.

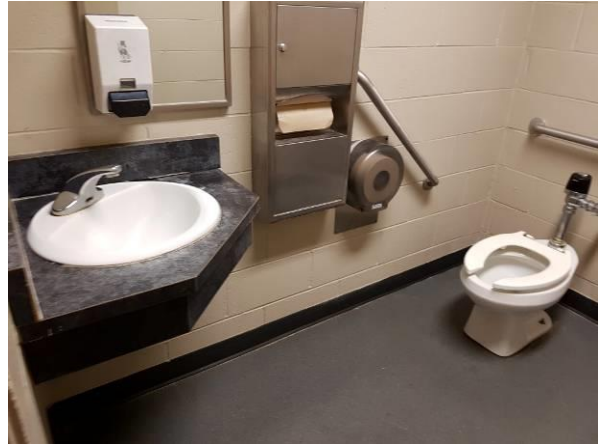
View showing the condition of the accessible washroom.

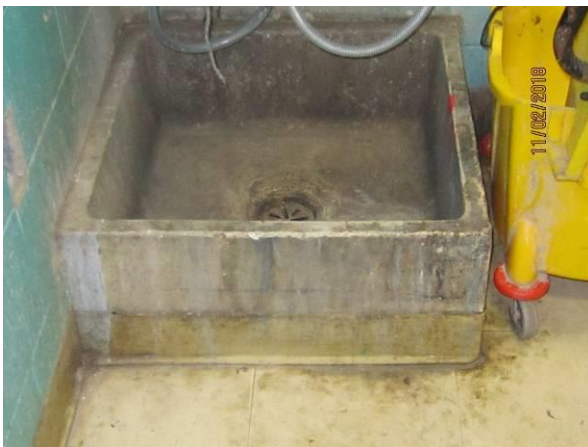
View showing the condition of floor sink in the janitor room.

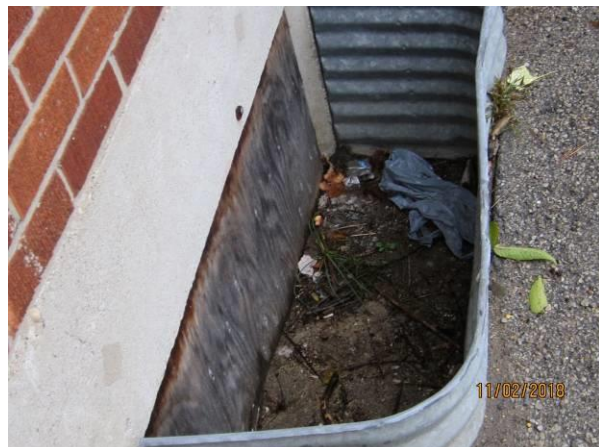
View showing the condition of the window well with blocked window in the basement- south elevation.

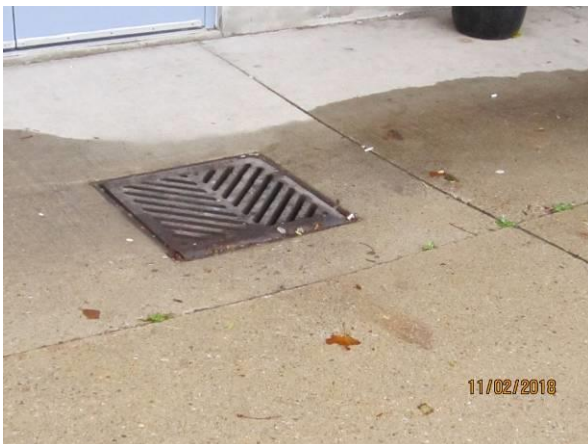
View showing the condition of the catch basin in front of the building.

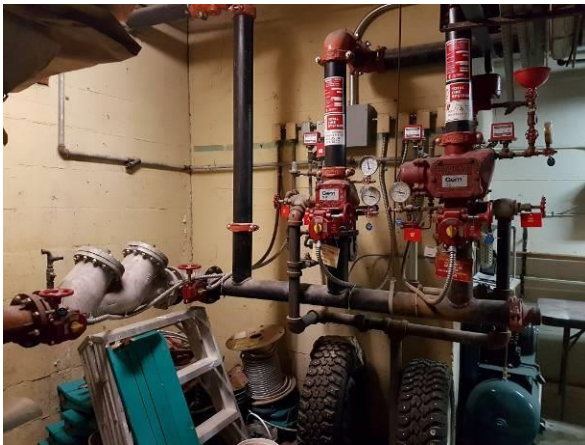
View showing the fire sprinkler system and valves.

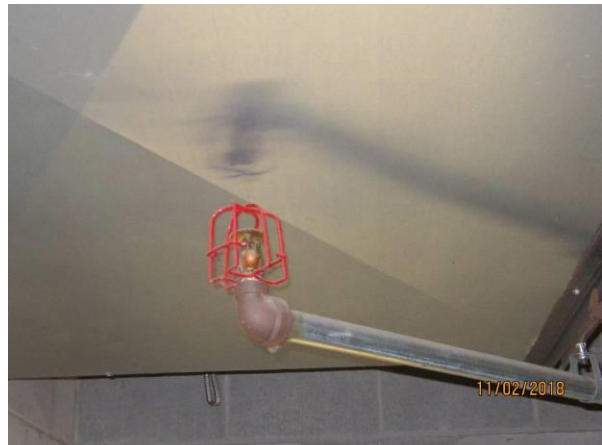
View showing the condition of the sprinkler heads.

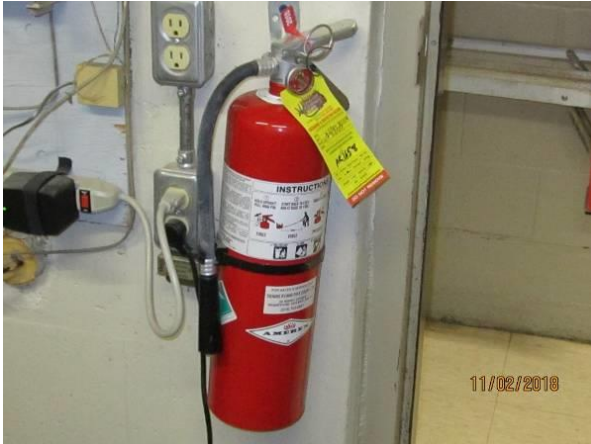
View showing typical condition of the fire extinguishers.

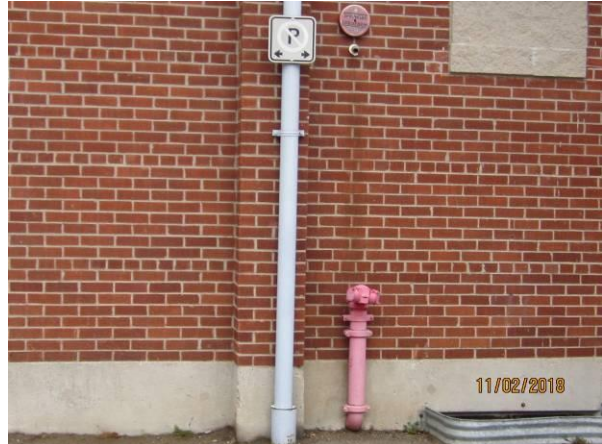
View showing the Siamese connection at the south elevation.

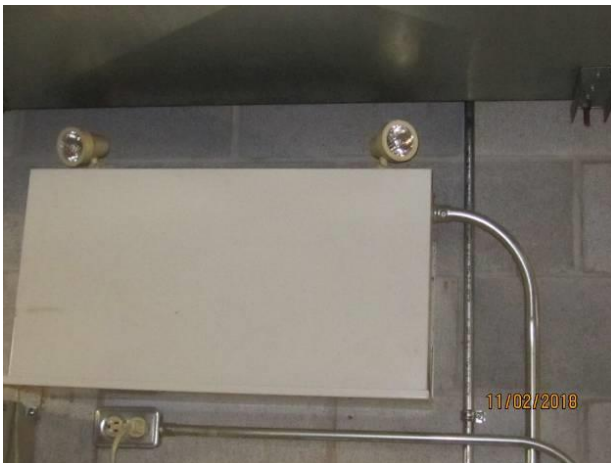
View showing the condition of the emergency light in the building.

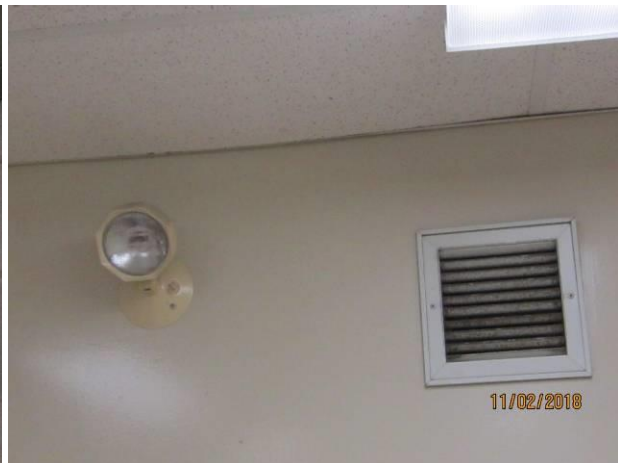
View showing the condition of the emergency light in the building.

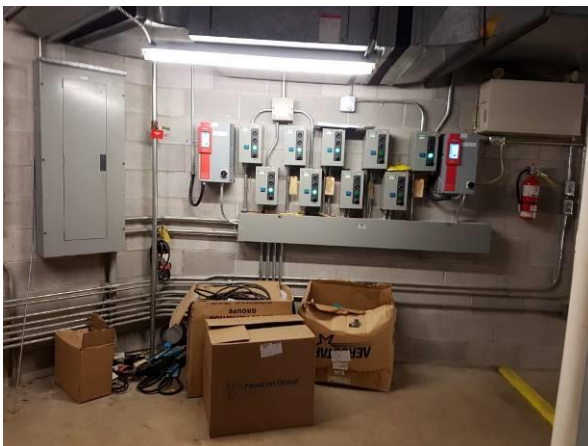
View showing the condition of the electrical panels in the penthouse.

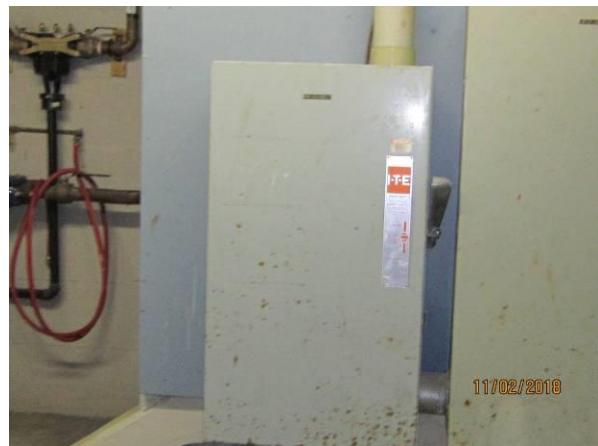
View showing the condition of the main disconnect.

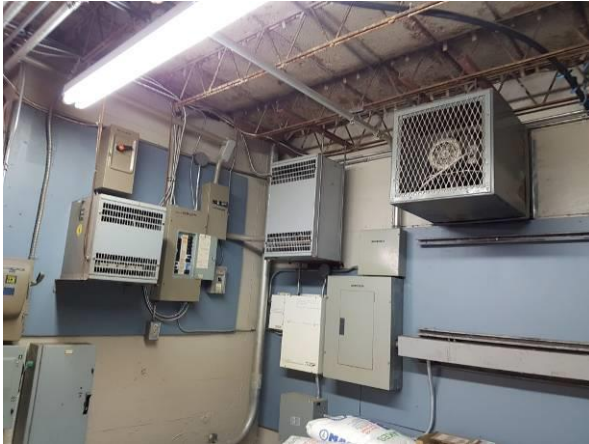
View showing the condition of the transformers and electrical panels in the refrigerator room

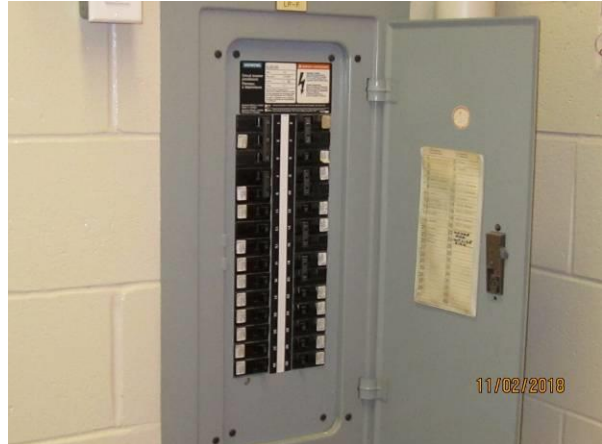
View showing the typical condition of the breaker panels.

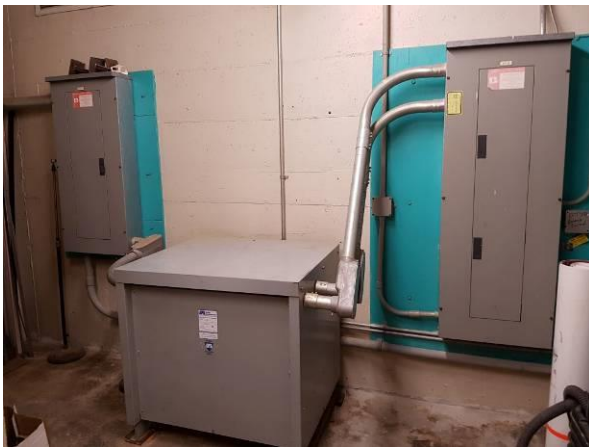
View showing the condition of the transformer and breaker panels in the main electrical room.

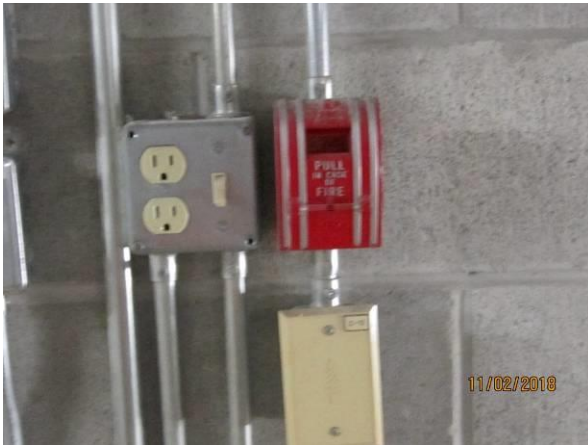
View showing the condition of the pull stations.

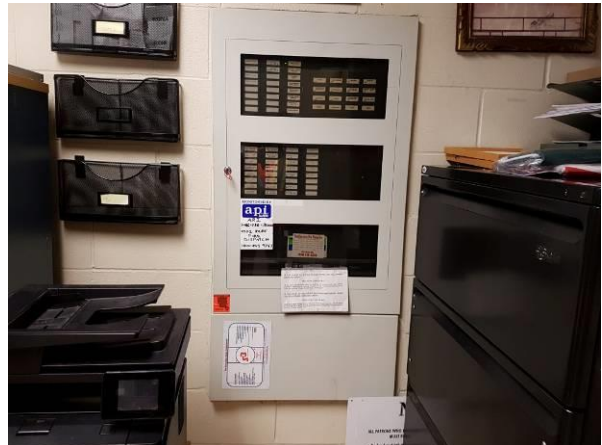
View showing the condition of the fire alarm panel in main/front office.

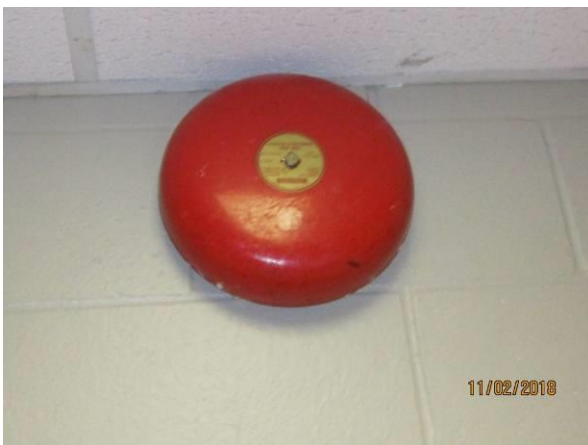
View showing the condition of the fire bell.

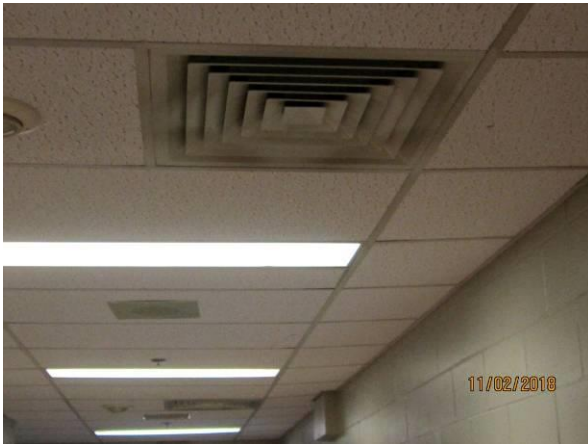
View showing the condition of the interior lighting.

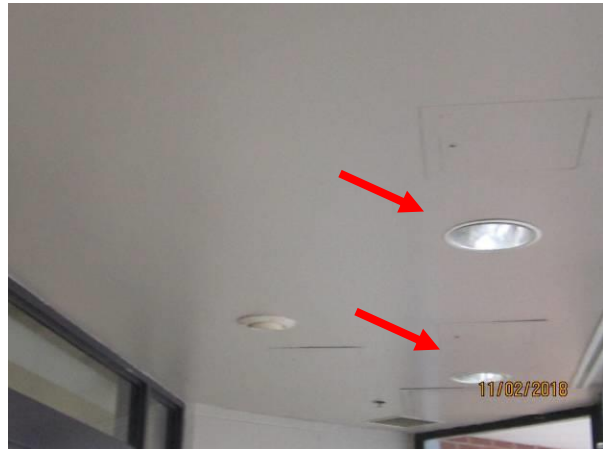
View showing the condition of the interior recessed light fixtures.

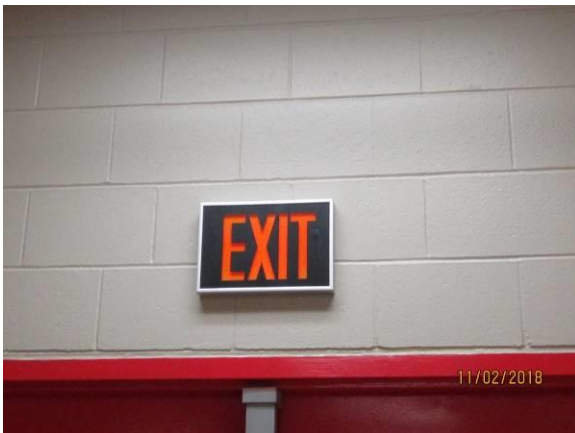
View showing the condition of the lighted exit fixtures in the building.

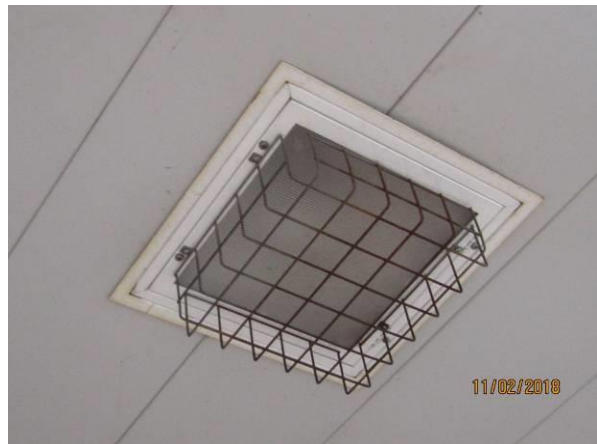
View showing the condition of the ceiling mounted light fixture on the exterior soffit.

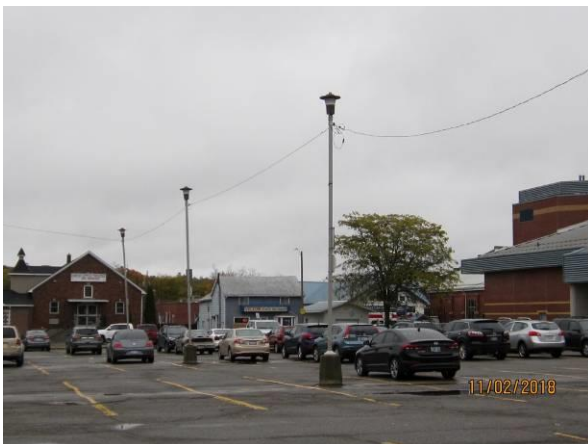
View showing the condition of pole-mounted exterior lighting in the parking lot.

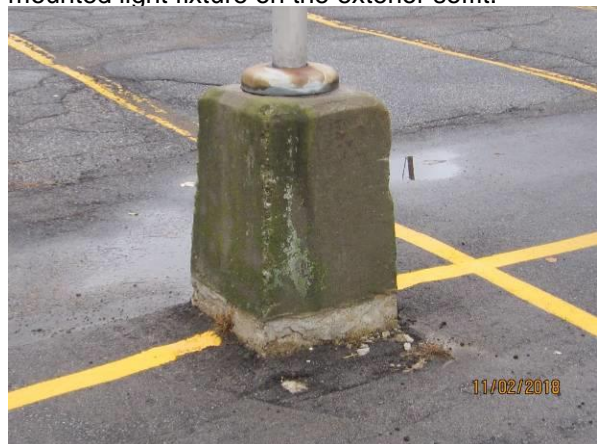
View showing damaged concrete base for pole-mounted exterior lighting.
