Norfolk County Lake Erie Hazard Mapping and Risk Assessment

Technical Report

March 19, 2020 | 13146.101.R2.Rev3

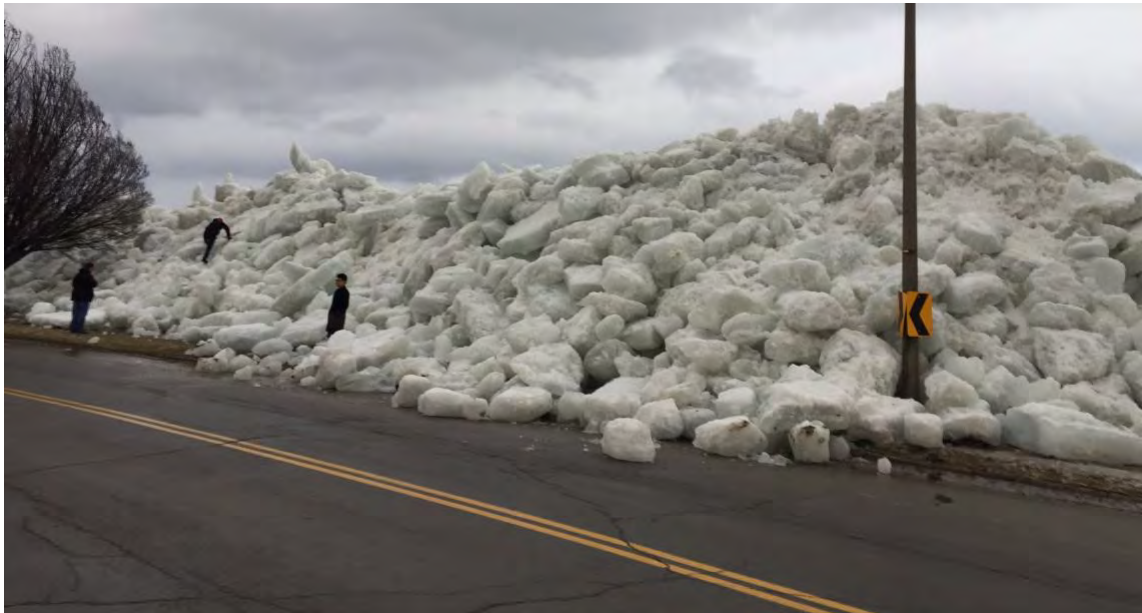
Figure 6.8: Ice pile-up along Lake Erie shoreline in Fort Erie, Ontario during Feb 25, 2019 (Mazza, 2019)

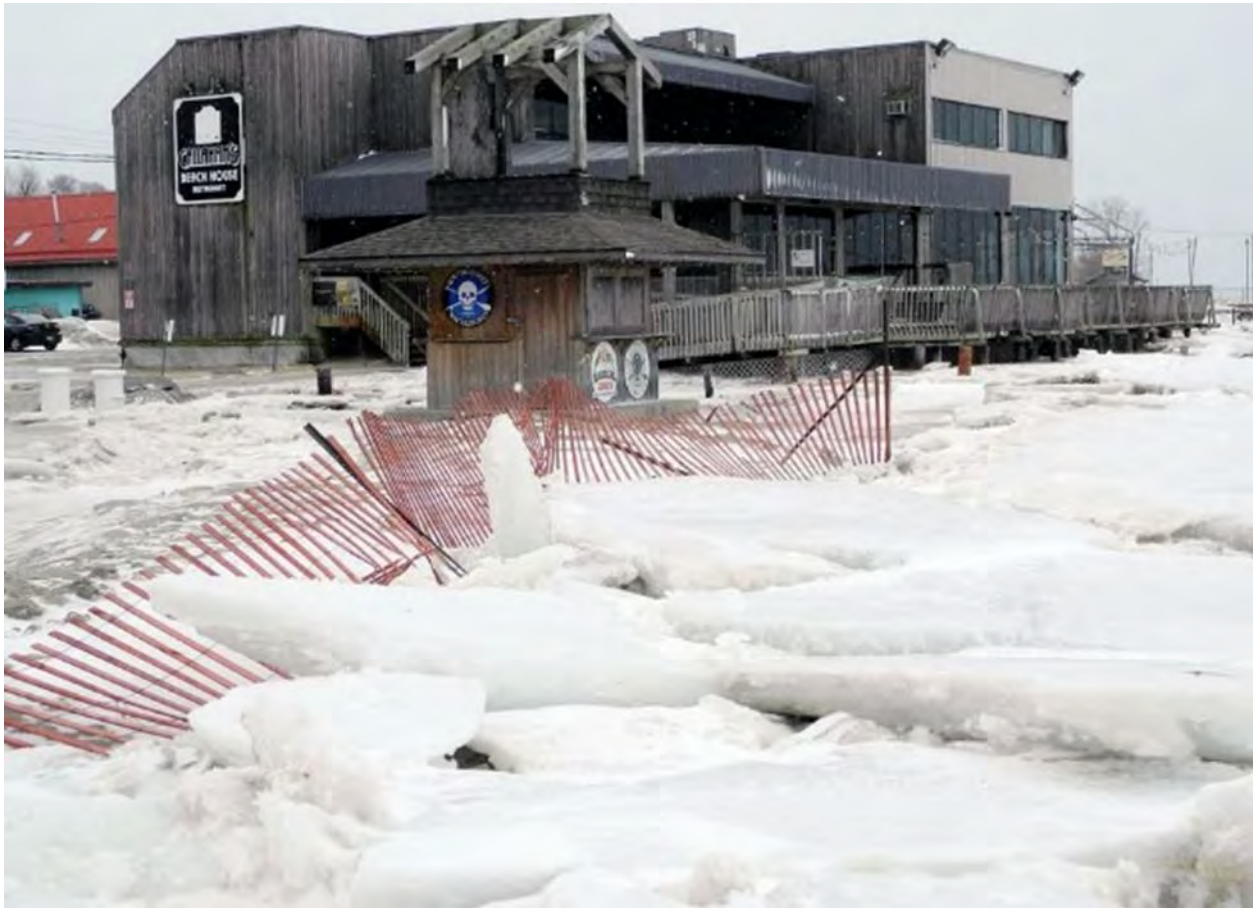
During this same storm event, strong winds and high lake levels resulted in ice piling and slush deposits onto roads near Walker St. Beach in Port Dover, and Willow Beach Lane in Simcoe (Figure 6.9). At Port Dover, the ice migrated landward up to approximately 50 m from shore near Walker St. Beach and resulted in minor damage to structures and infrastructure. The pile-up that occurred in Port Dover was in the form of large ice sheets that were pushed ashore, as opposed to large piles of broken ice rubble (such as in Figure 6.8).

Figure 6.9: Ice pile-up along Walker St. in Port Dover, at The Beach House looking East (Sonnenberg, 2019)

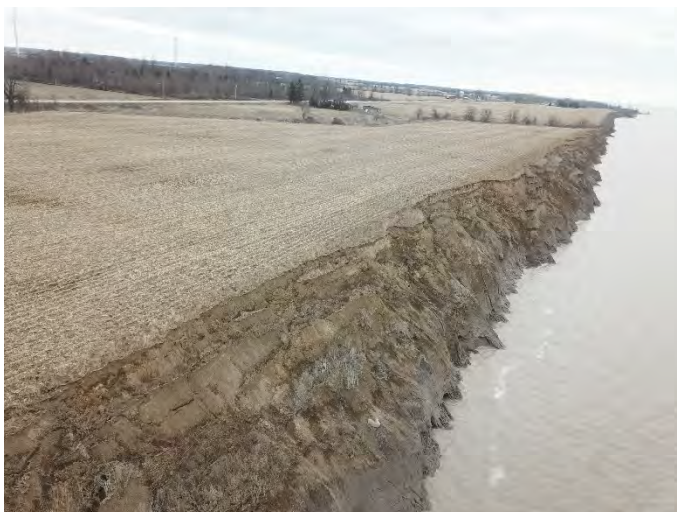
Photograph 6

Location: Slope at Section T6
Viewing: West
Description: The slope at this section is bare. The stratigraphy of the slope is visible in the slope face. There is some seepage visible in the lower slope face.

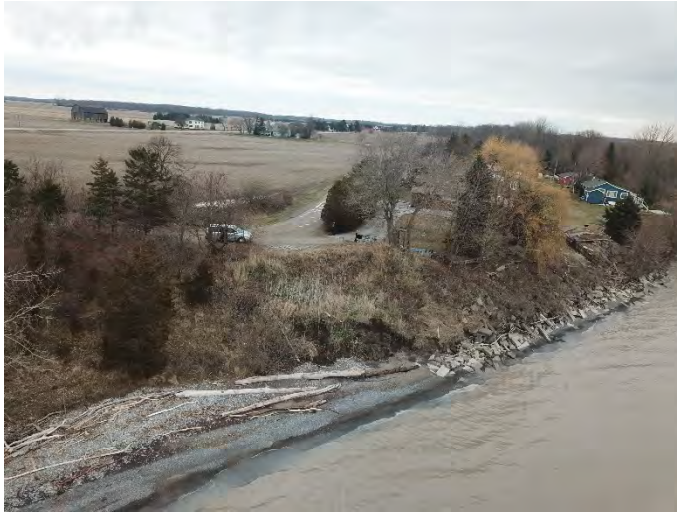
Photograph 7

Location: Slope at Section T13
Viewing: East
Description: The slope face is bare. The soil stratigraphy is visible in the slope face. The upper layer of sand is retrogressively failing.

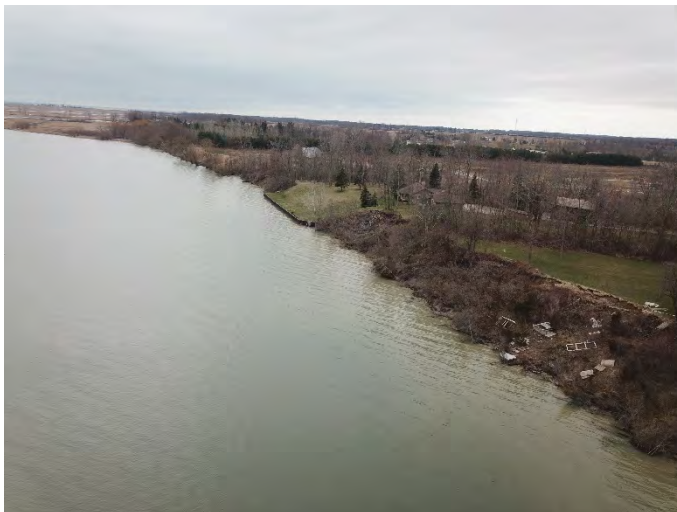
Photograph 8

Location: Slope at Section T15
Viewing: East
Description: The slope at this section is vegetated with shrubs. There is rubble fill down the slope face and at the toe of slope.

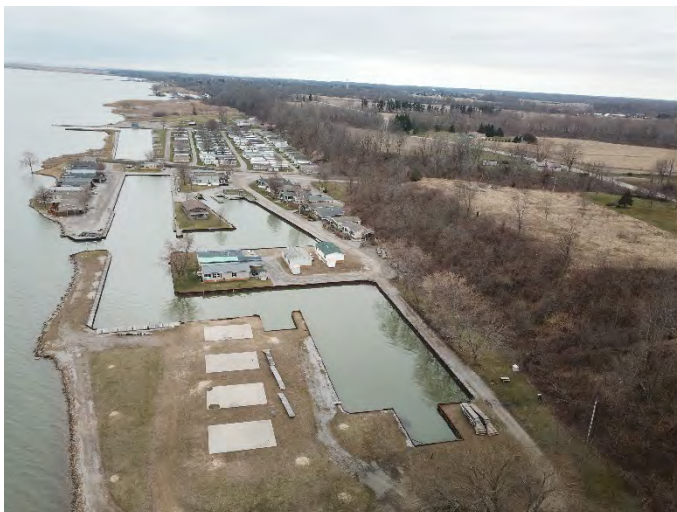
Photograph 9

Location: Slope at Section T29
Viewing: West
Description: The slope at this section is landscaped with grass. There's a wall at the toe of slope. East of the section there is debris on the slope face and bare soil. Possibly retrogressive failure.

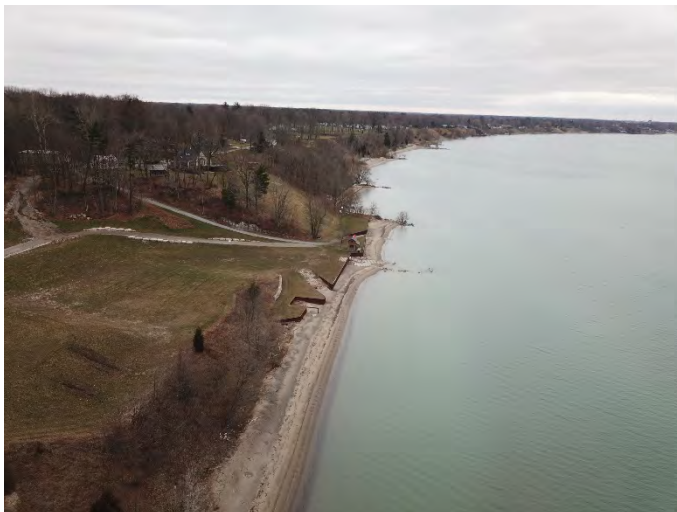
Photograph 26

Location: Slope at Section T52
Viewing: East
Description: The upper slope is vegetated and the lower slope is bare. No seepage observed through the slope face.
