Norfolk County Lake Erie Hazard Mapping and Risk Assessment

Technical Report

March 19, 2020 | 13146.101.R2.Rev3

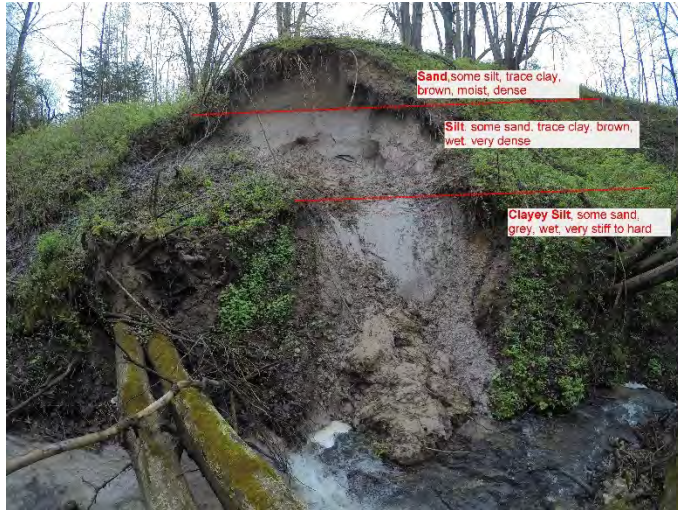
Photograph 1

Location: North of Section T1
Viewing: East towards gully face
Description: The soil stratigraphy around Section T1 is visible in a gully north of the Lake Erie shoreline. The stratigraphy consists of sand, over silt, over clayey silt.

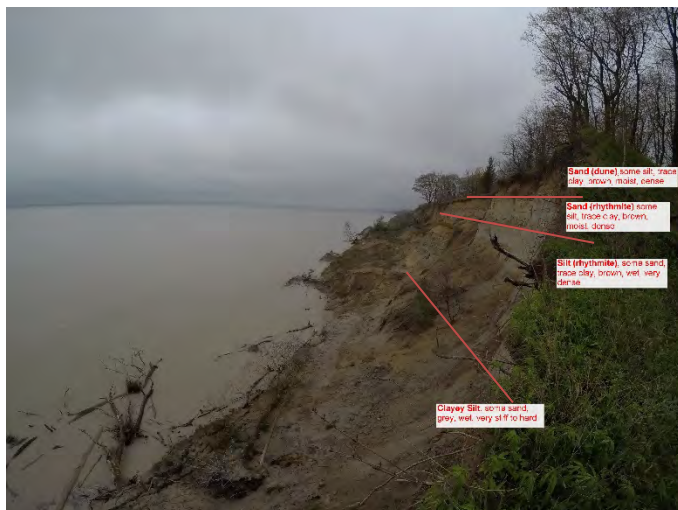
Photograph 2

Location: East of Section T1
Viewing: West
Description: The stratigraphy of the shoreline east of Section T1 is visible. Sand talus has accumulated at the toe of slope. There is no seepage visible through the slope face.

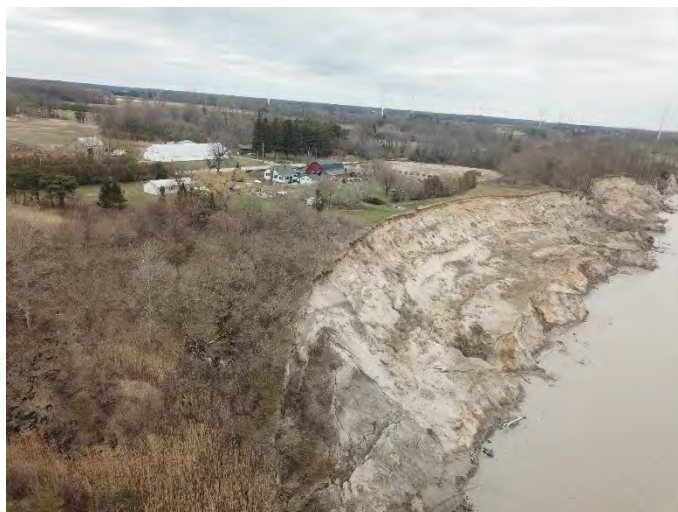
Photograph 3

Location: Slope at Section T1
Viewing: West
Description: The slope at Section T1 is bare. There is talus accumulation at the toe of slope. Some seepage is visible through the lower slope face.

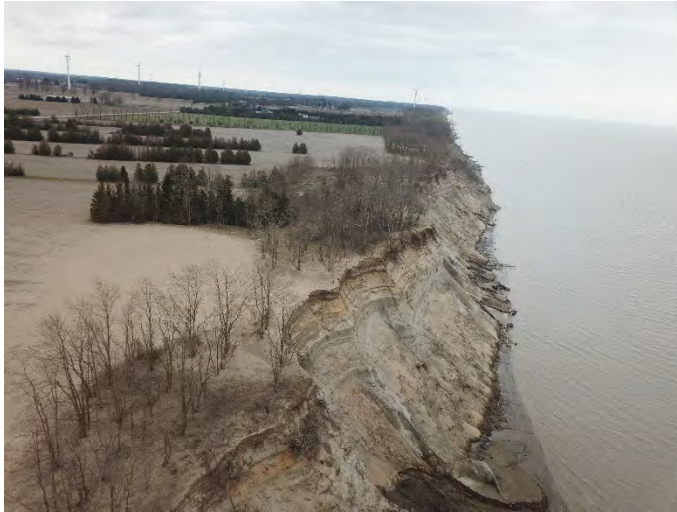
Photograph 4

Location: Slope west of Section T4
Viewing: East
Description: The soil stratigraphy is visible in the bare slope face. There is some talus accumulation at the toe of slope. Seepage is visible at the toe of slope.

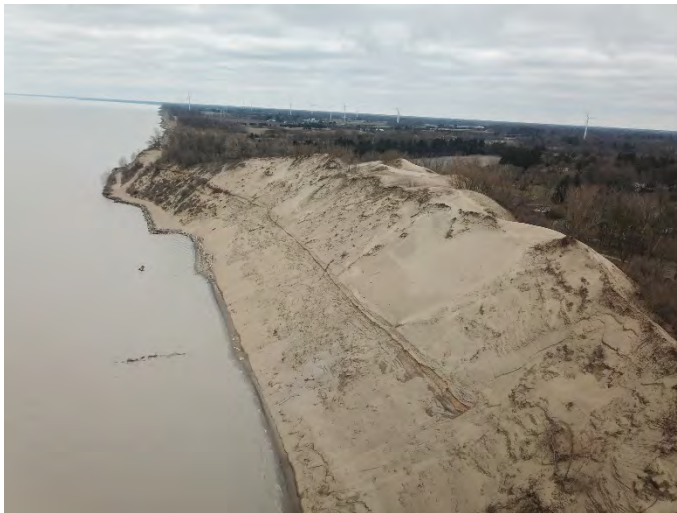
Photograph 5

Location: Slope at Section T6
Viewing: West
Description: The slope at this section is bare. The stratigraphy of the slope is visible in the slope face. There is some seepage visible in the lower slope face.

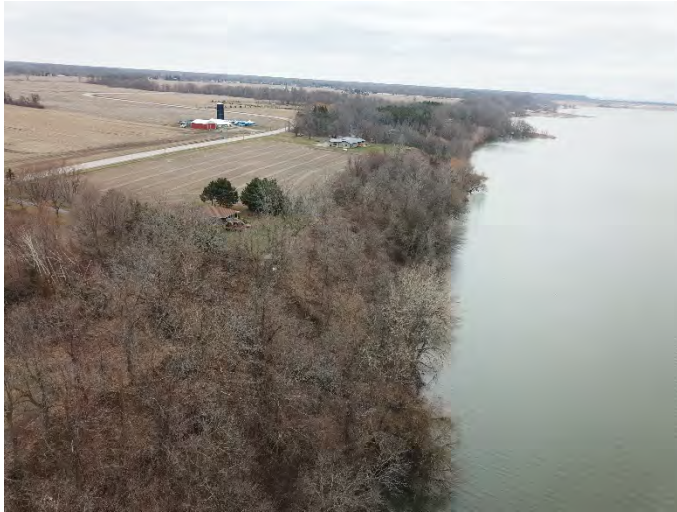
Photograph 10

Location: Slope at Section T31
Viewing: East
Description: The slope is densely vegetated. There are some dwellings in close proximity to the slope crest.

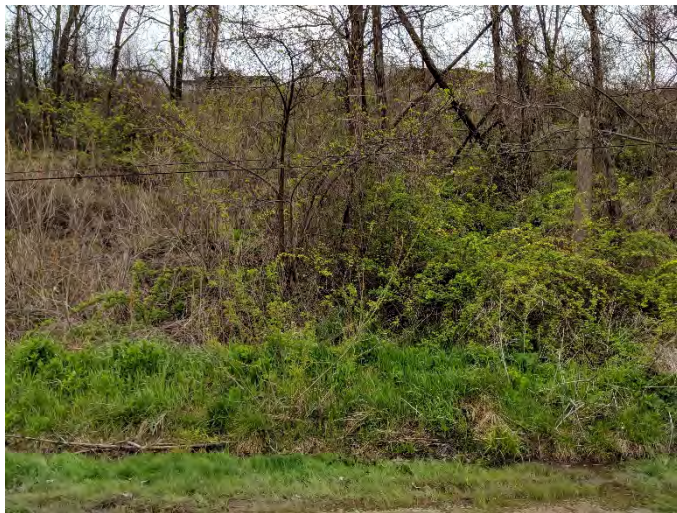
Photograph 11

Location: Slope at Section T32
Viewing: North
Description: The slope is densely vegetated. There is a marina at the toe of slope.

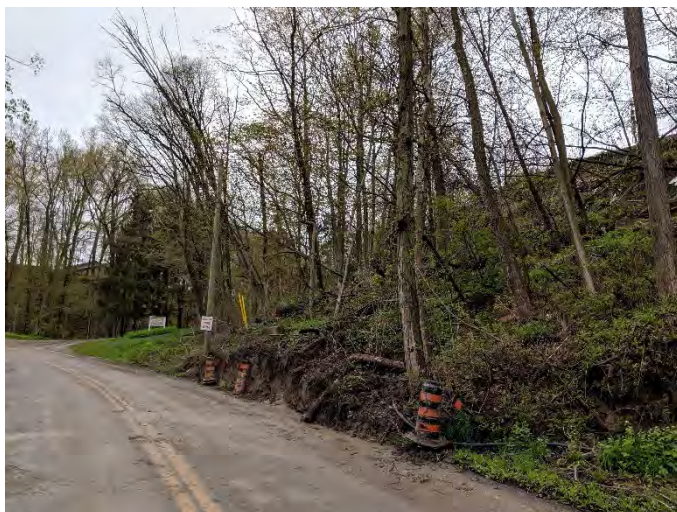
Photograph 12

Location: Slope in north of Section T32
Viewing: North
Description: There are leaning trees on the slope face, with exposed bare soil on the roadway down to Section T32. The soil composition is a silt and clay.

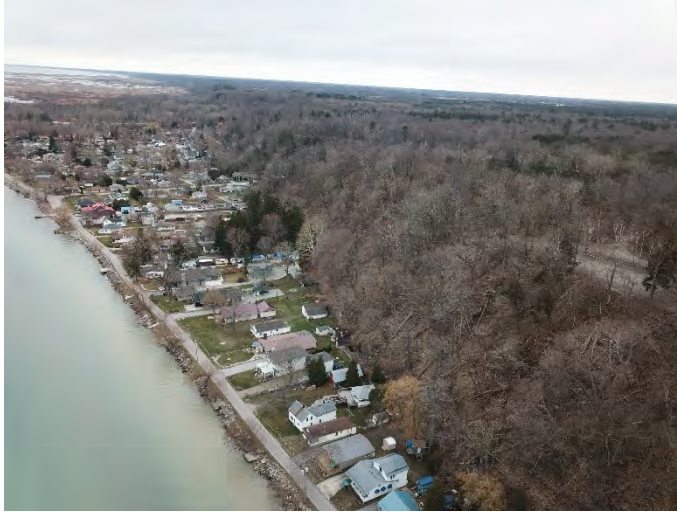
Photograph 13

Location: Slope at Section T37
Viewing: East
Description: The slope is densely vegetated. There are dwellings at the toe of slope.

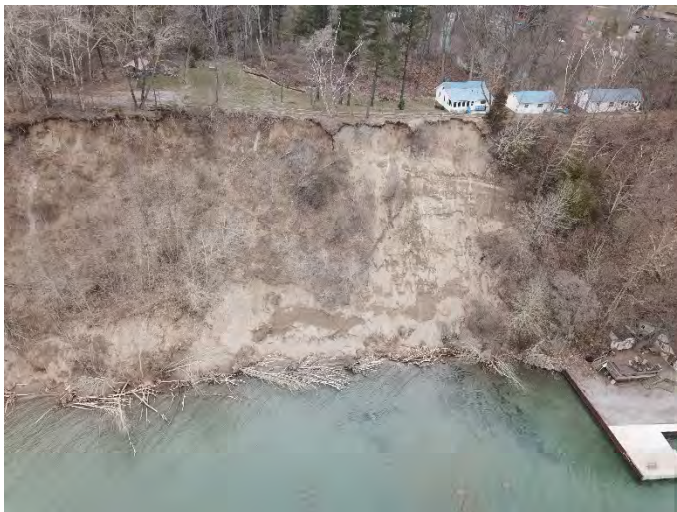
Photograph 14

Location: Slope at Section T38
Viewing: East
Description: The slope at this section is vegetated with some exposed bare soil.

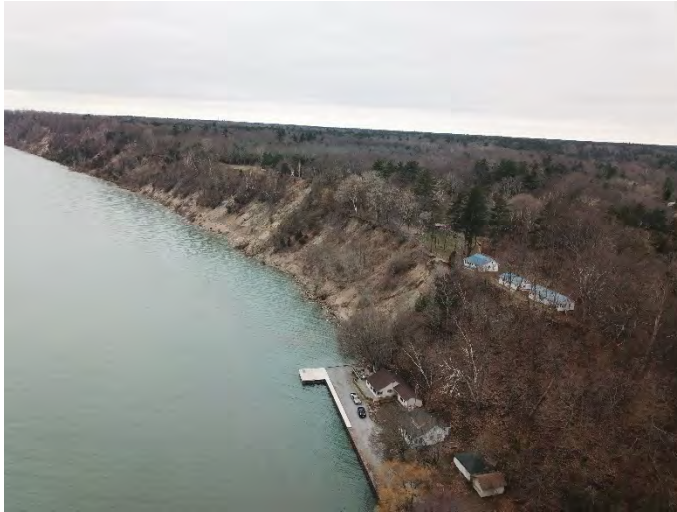
Photograph 15

Location: Slope west of Section T39
Viewing: North
Description: The slope west of T39 is bare and the soil stratigraphy is visible. There are dwellings in the tableland in close proximity to the slope crest.

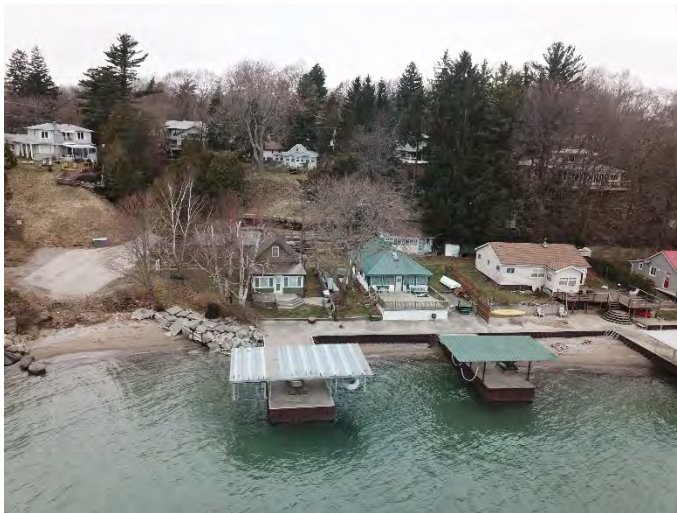
Photograph 16

Location: Slope at Section T39
Viewing: West
Description: The slope at Section T39 is vegetated.

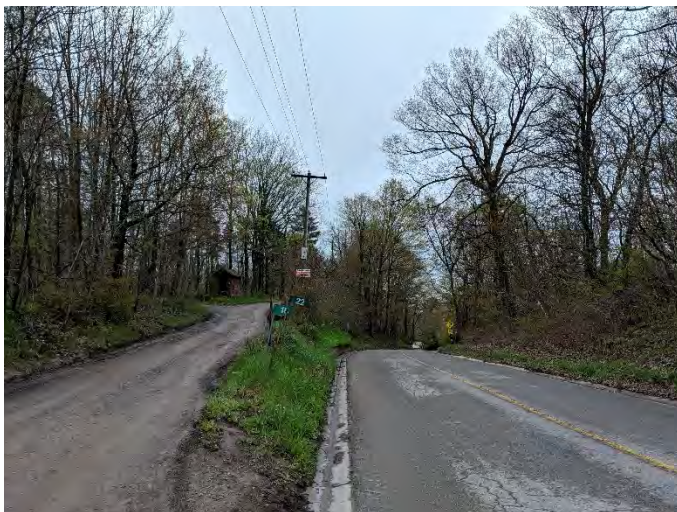
Photograph 17

Location: Slope at Section T40
Viewing: North
Description: There are dwellings at the toe of the slope and in the tableland. There is rubble fill at the toe of the slope.

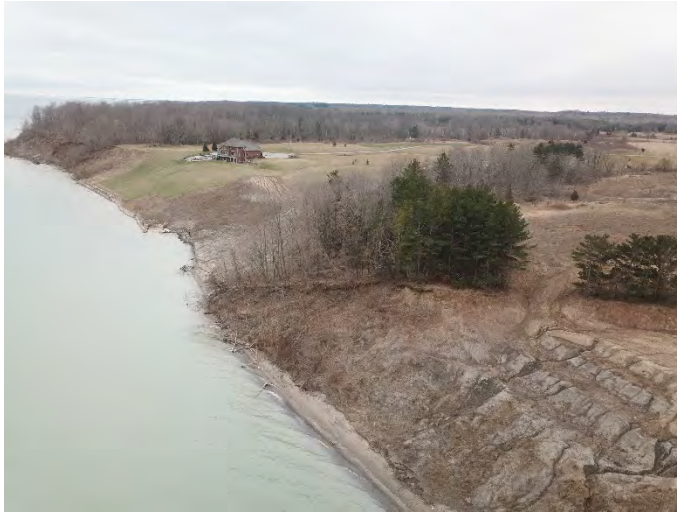
Photograph 18

Location: Back from Section T42
Viewing: South
Description: The slope at Section T42 is a local low compared to the adjacent lands.

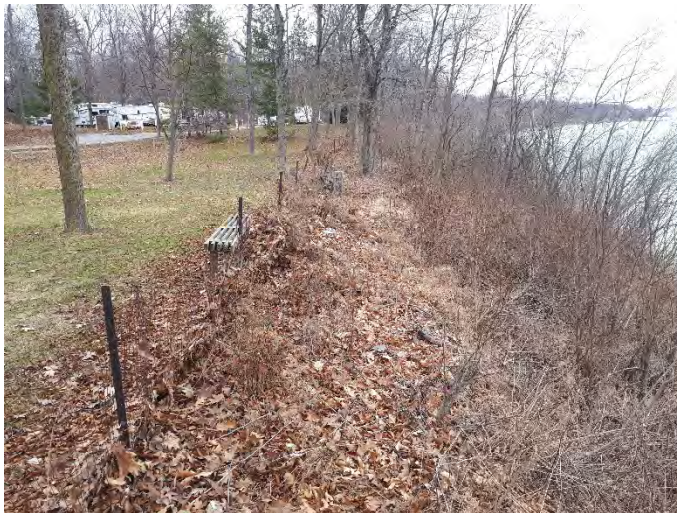
Photograph 19

Location: Slope at Section T46
Viewing: West
Description: The slope is vegetated with grass, and at a shallower inclination than the adjacent slope face.

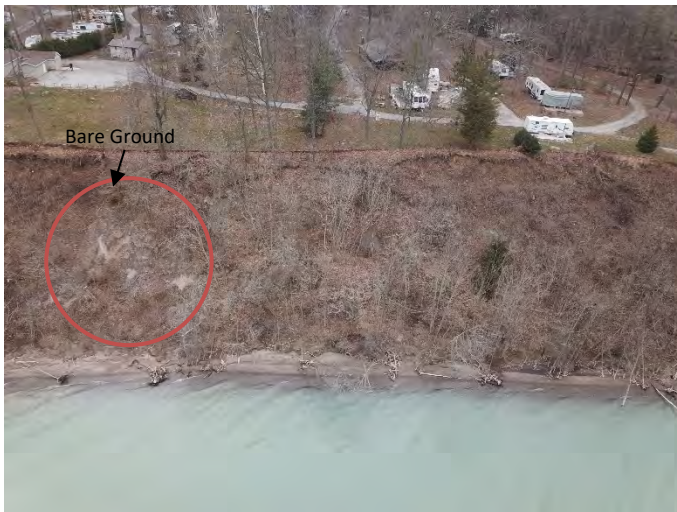
Photograph 20

Location: Slope crest at Section T47
Viewing: East towards Port Ryerse
Description: The slope is well vegetated with no signs of erosion.

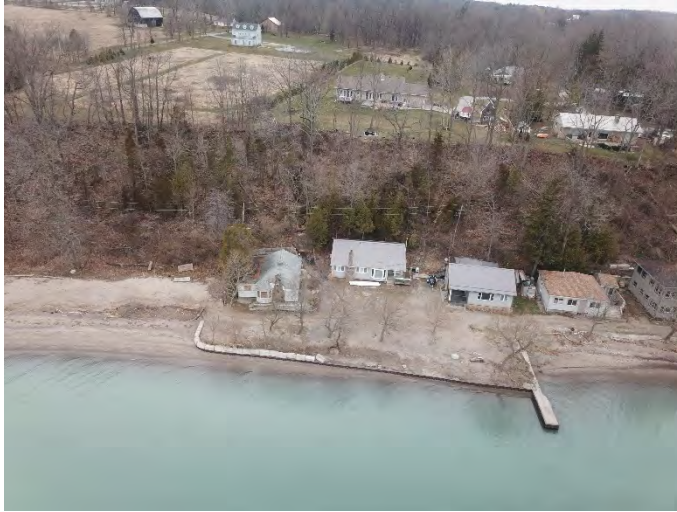
Photograph 21

Location: Slope at Section 47
Viewing: East
Description: The slope face is vegetated. There are bare areas on the slope face where the vegetation has sloughed off the slope face.

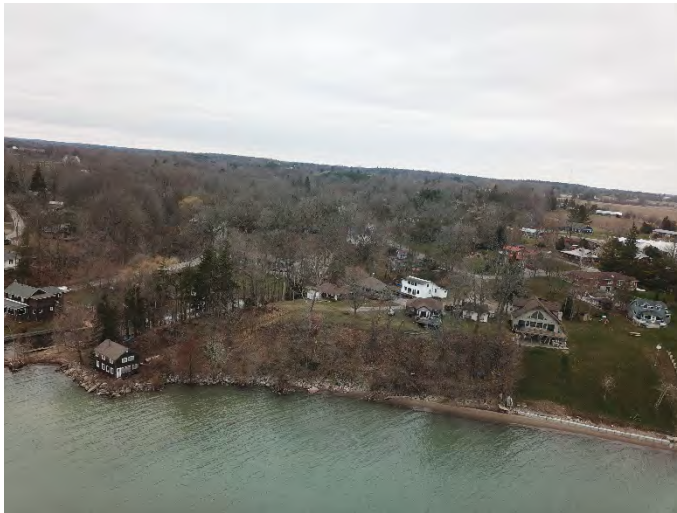
Photograph 22

Location: Slope at Section T48
Viewing: North
Description: The slope is well vegetated with no signs of erosion. There are dwellings at the toe of slope. There is a sand beach and a toe wall at the toe of slope.

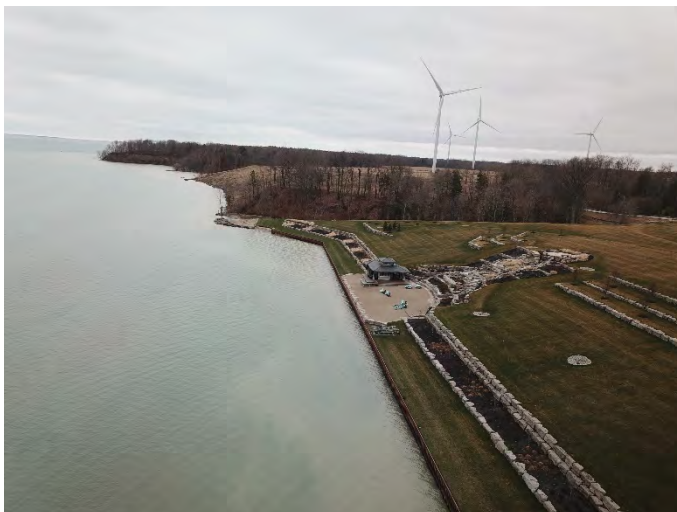
Photograph 23

Location: Slope at Section T49
Viewing: North
Description: The slope is well vegetated with no signs of erosion. There is concrete rubble at the toe of slope.

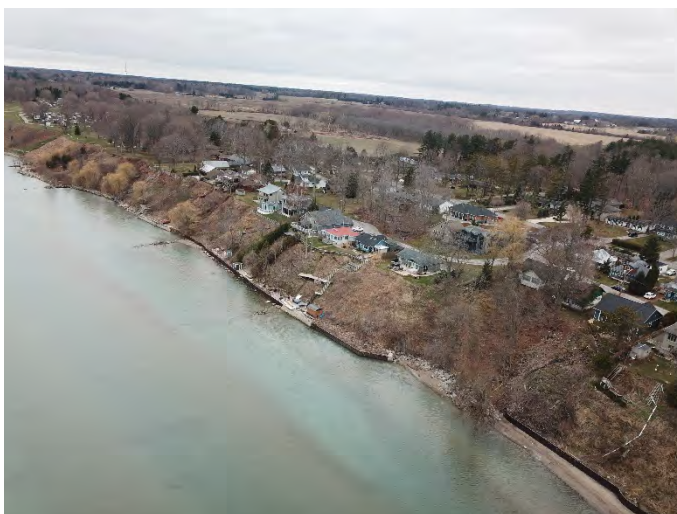
Photograph 26

Location: West of the slope at Section T53
Viewing: East
Description: The slope at Section T53 is vegetated.

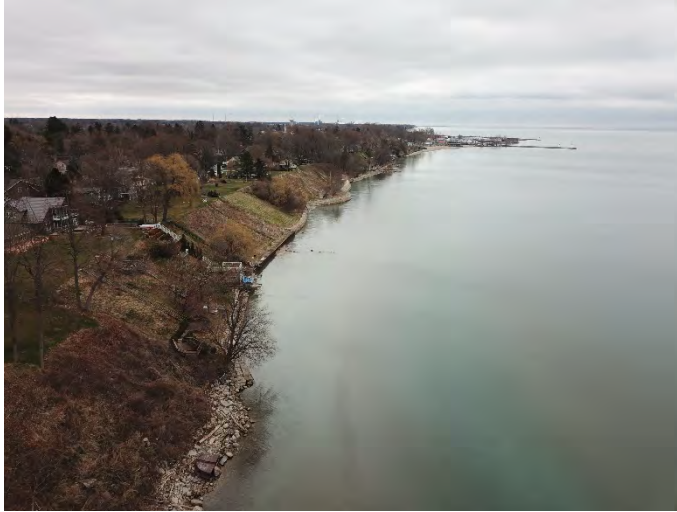
Photograph 27

Location: East of the slope at Section T54
Viewing: West
Description: The slope at Section T52 appears sparsely vegetated on the upper slope face and well vegetated on the lower slope face.

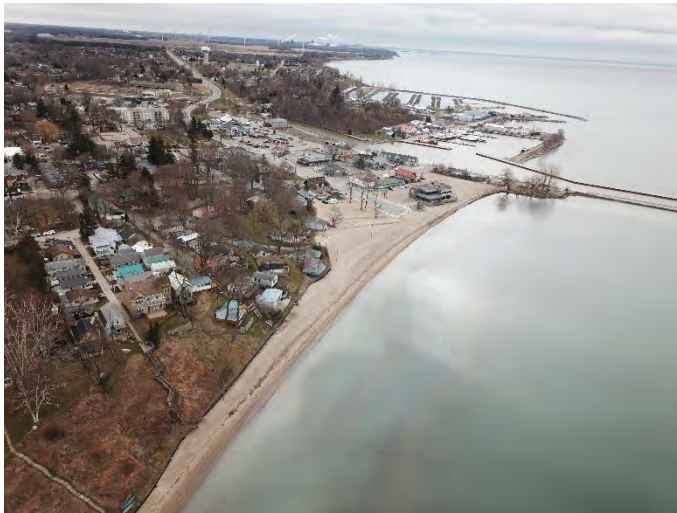
Photograph 28

Location: West of the slope at Section T55
Viewing: East
Description: The slope at Section T55 is vegetated with young trees. There is a wall at the toe of slope.

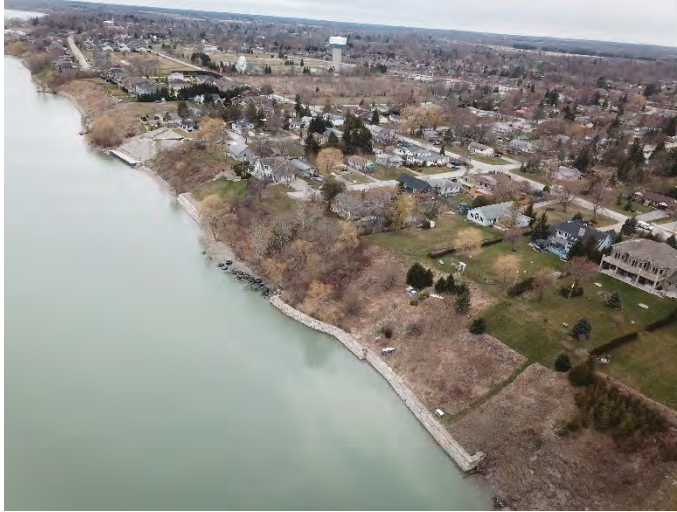
Photograph 30

Location: Section T57
Viewing: North
Description: There is a marina at the shoreline at Section T57. The slope at this section is paved with asphalt. The slope west of this section is well vegetated.

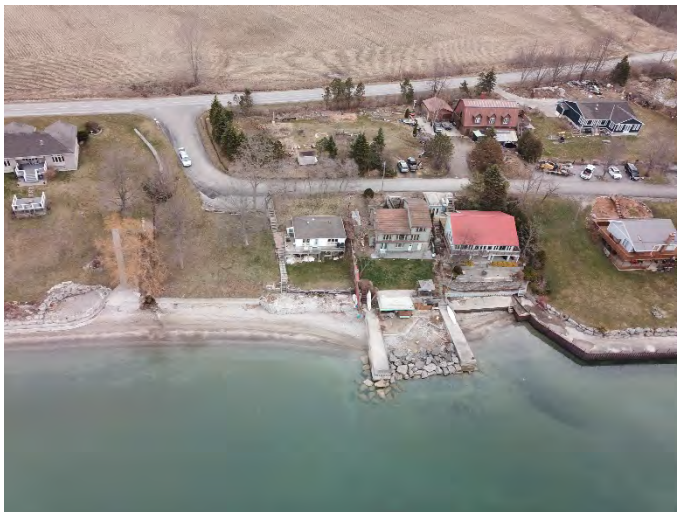
Photograph 31

Location: Section T58
Viewing: West
Description: The slope at this section has a sand beach at the toe. There are tires along the shoreline. The slope is vegetated with young to mature trees.

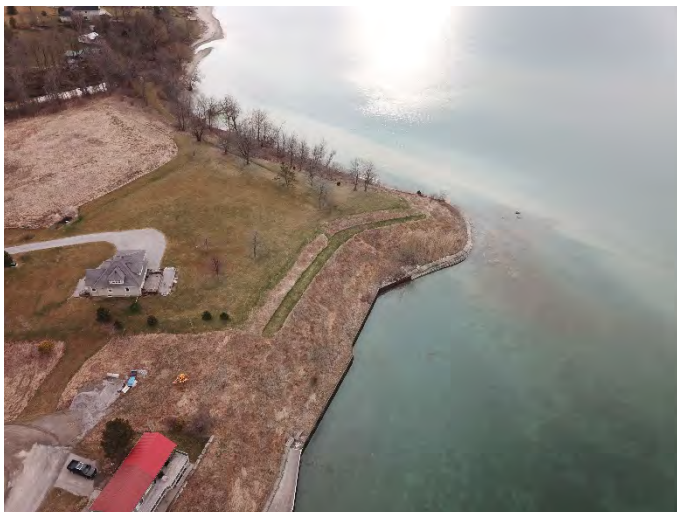
Photograph 32

Location: Section T61
Viewing: North
Description: The slope at this section is vegetated with grass. There is a concrete wall at the toe of slope, with a sand beach at the shoreline.

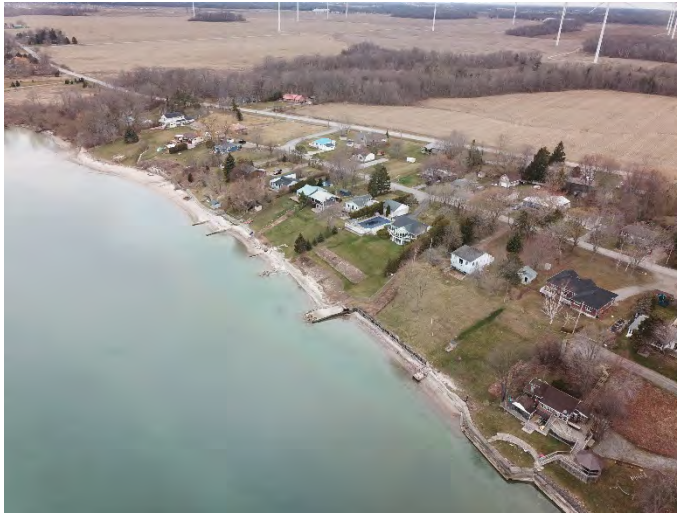
Photograph 33

Location: Section T62
Viewing: East
Description: The slope at this section is vegetated with young trees. Limestone is visible under the water.

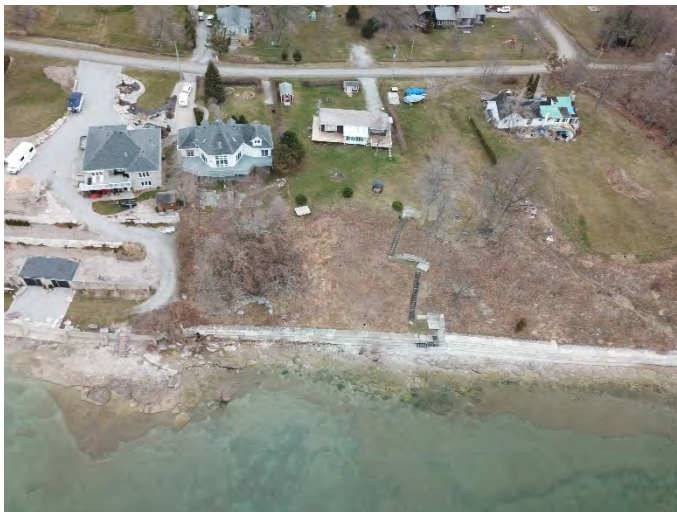
Photograph 34

Location: Slope at Section T63
Viewing: North
Description: There is a wooden wall at the toe of slope, with a sand beach at the shoreline. The slope is vegetated with grass.
